MAIN HEAT TRANSFER SYSTEM

Customer: PTRHTF30004	System Information	Sample Information
AUTOLIV CANADA 20 AUTOLIV DRIVE P.O. BOX 1090 TILBURY, ON N0P 2L0 Canada Attn: TODD MARYSCHAK Tel: (519)380-6564 E-Mail: todd.maryschak@autoliv.com	System Volume: 4100 ltr Bulk Operating Temp: 271F / 133C Heating Source: Blanket: Fluid: PETRO CANADA CALFLO AF Make:	Lab No: 01845481 Analyst: Michael Kaufman Sample Date: 03/22/13 Received Date: 06/20/13 Completed: 06/24/13 Michael Kaufman mkaufman@suncor.com

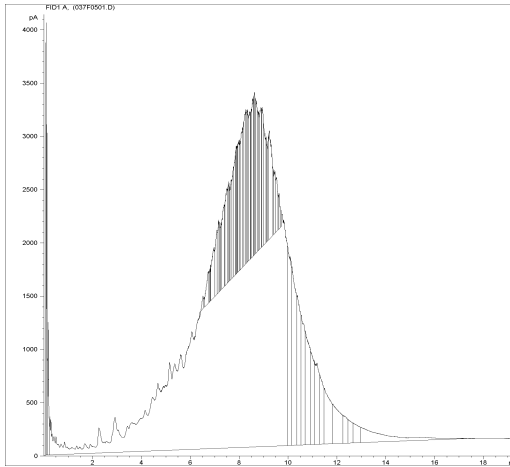
GCD Spectrum

Comments: (GCD) % < 335°C is severely high. (GCD) 10% Distillation Point is severely low. COC Flash Point is abnormally low. (GCD) 50% Distillation Point is marginally low. (GCD) 90% Distillation Point is marginally low.

Recommendation: Similar to Boiler #1+2, the oil has been severely degraded. The flash point has dropped significantly and the GCD<335 has also risen. We recommend venting the system as soon as safely possible to remove the low boilers. Please contact your local Petro-Canada technical advisor for general guidelines on venting and removal of light hydrocarbons from your system.
