AUTOLIV BOILER #2

| Customer: PTRHTF30004 | System Information | Sample Information |

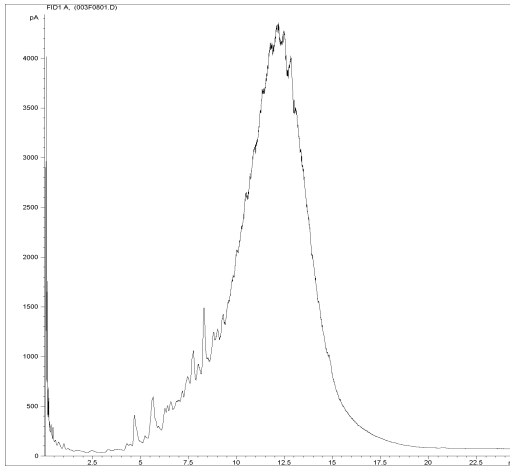
GCD Spectrum

Comments: (GCD) 10% Distillation Point is severely low. COC Flash Point is severely low. (GCD) % < 335°C is abnormally high.

Recommendation: Viscosity of the Calflo AF has been reduced to 21.6 cSt @40°C from a typical of 32.3 cSt @ 40°C. Possible cracking of the fluid has occurred, or another product has been added. Percent of boilers <335°C is quite high @ 13.80% and 10% point has been reduced to 313.5°C from a typical of 365°C. Consider venting system to reduce light boilers. Consider bleeding off some fluid and sweetening with Calflo AF to increase viscosity of fluid. Sulphur and Phosphorus additive levels are not consistent with Calflo AF. Confirm that Calflo AF is being used and topped up. Resample at 3 months after venting to confirm if low boilers have been reduced. Consider bleeding off some fluid and sweetening with Calflo AF to increase flash point and reduce low boilers.
