## TFS H/O SYSTEM #2

Customer: PTRHTF10176	System Information	Sample Information
CERTAINTEED ROOFING	System Volume: 3738 gal	Lab No: 02211309
100 CERTAINTEED DR	Bulk Operating Temp: 525F / 274C	Analyst: Gaston Arseneault
JONESBURG, MO 63351 USA	Heating Source:	Sample Date: 04/09/18
Attn: Randy Smith	Blanket:	Received Date: 04/20/18
Tel: (636)791-3651	Fluid: PETRO CANADA CALFLO AF	Completed: 05/16/18
E-Mail: randy.smith@saint-gobain.com	Make: FSE	To discuss this report contact Gaston
		Arseneault at 973-986-6503

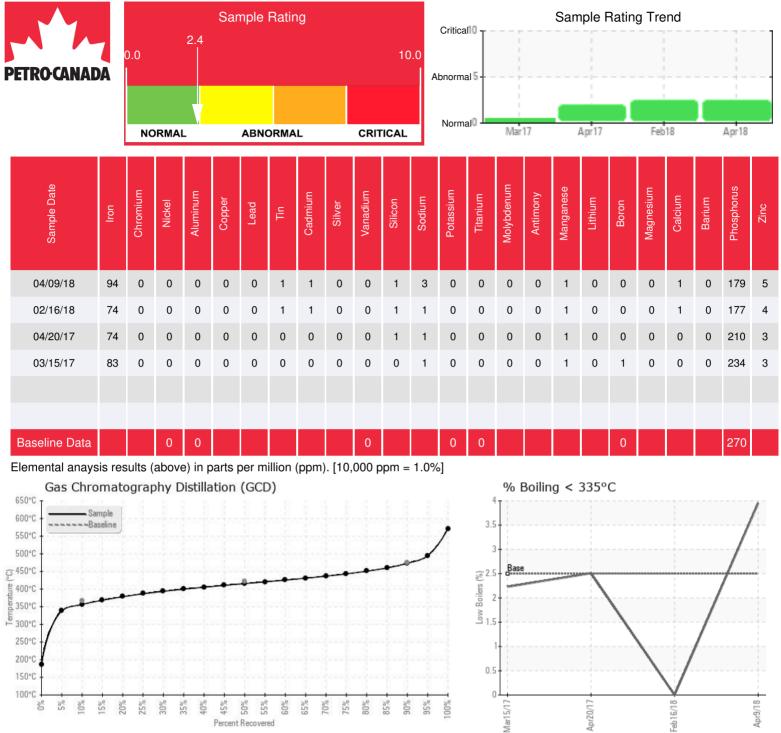
Percent Recovered

Comments: COC Flash Point is marginally low.

Recommendation: The results are almost identical to the satisfactory results from a couple months ago. No action needed at this time besides re-sampling in about 6-9 months time.
