SUPPLY CARGILL MEAT THAILAND

Customer: PTRHTF60010	System Information	Sample Information
SYNLUBE INTERNATIONAL CO LTD 76/1 MOO.7 THACHIN MUANG SAMUTSAKHON, 74000 THAILAND Attn: Kittisak Suthithanakom Tel: 6(681)850-1907 E-Mail: kittisak@synlube.co.th	System Volume: 9635 ltr Bulk Operating Temp: 554F / 290C Heating Source: Blanket: Fluid: PETRO CANADA PURITY FG HEAT TRANSFER FLUID Make: WANSON	Lab No: 02221715 Analyst: Yutong Gao Sample Date: 05/23/18 Received Date: 06/12/18 Completed: 06/17/18 To discuss this report contact Yutong Gao at (403)873-1876

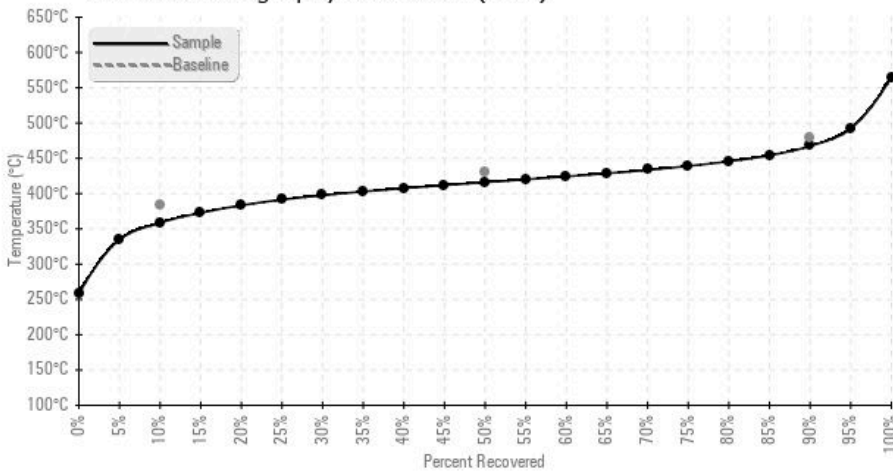
Gas Chromatography Distillation (GCD)

Comments: COC Flash Point is severely low. (GCD) 90% Distillation Point is marginally low.

Recommendation: The currently fluid has experienced severe thermal cracking at the extremely high bulk working temperature. However, the fluid flash point and viscosity are all higher than the previous three used oil samples, so the overall fluid conditions are improving. Please continue to do the effective system venting and take one sample in 6 months to monitor the conditions.
