GFPT-FURTHER#1#2

Customer: PTRHTF60010	System Information	Sample Information
SYNLUBE INTERNATIONAL CO LTD 76/1 MOO.7 THACHIN MUANG SAMUTSAKHON, 74000 THAILAND Attn: CHERNPORN CHOBKUI Tel: 034421290 E-Mail: chernporn@synlube.co.th	System Volume: 7000 ltr Bulk Operating Temp: 554F / 290C Heating Source: Blanket: Fluid: PETRO CANADA PURITY FG HEAT TRANSFER FLUID Make: WANSON	Lab No: 02221716 Analyst: Yutong Gao Sample Date: 04/18/18 Received Date: 06/12/18 Completed: 06/17/18 To discuss this report contact Yutong Gao at (403)873-1876

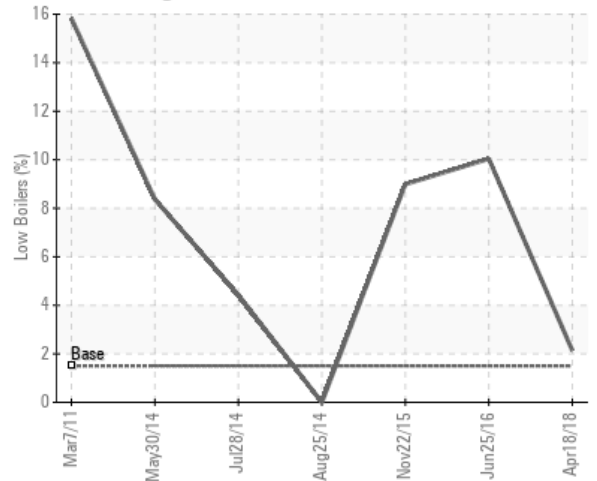
% Boiling < 335°C

06/25/16	(GCD) % < 335°C is abnormally high. COC Flash Point is abnormally low. (GCD) 10% Distillation Point is abnormally low. The current fluid has been thermal cracked. The high content of light boiler causes the low flash point. The system venting is required as soon as possible, otherwise the partial oil change is recommended. Please confirm the oil working hours to assist the oil analysis data interpretation.
11/22/15	The fluid experienced moderate thermal cracking, there are some light end of the fluid accumulated in the system. GCD%<335C data reading is high, the flash point is low. Please do the effective system venting as soon as possible. Please take one sample in 6~8 months to monitor the conditions. (GCD) 10% Distillation Point is low. (GCD) % < 335°C is marginally high.
08/25/14	The current fluid is in good conditions. Especially, the flash point has increased a lot comparing with the last two samples. Please take one sample in 3 months to monitor. (GCD) 90% Distillation Point is lower than the new fluid.
