[KEYERA PARTNERSHIP / 3-12-46-14W5] PLANT 2

System Information
 System Volume: 14000 ltr
 Bulk Operating Temp: 455F / 235C
 Heating Source:
 Blanket:
 Fluid: PETRO CANADA PETRO-THERM
 Make: PETROTHERM ENG.

Sample Information
 Lab No: 02227254
 Analyst: Kevin McDermott
 Sample Date: 06/28/18
 Received Date: 07/10/18
 Completed: 07/12/18
 Kevin McDermott
 kevin.mcdermott@hollyfrontier.com

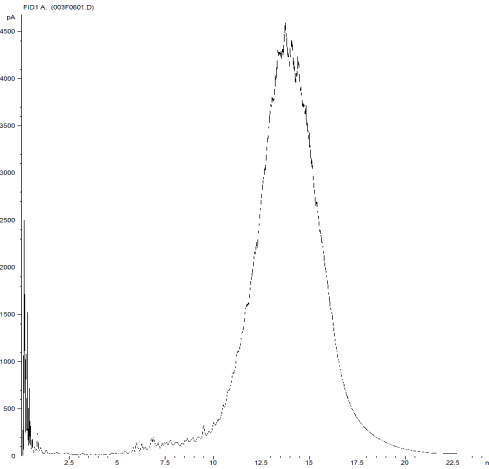
GCD Spectrum

Recommendation: Flash point is very low, viscosity slightly lower, both caused by dilution from blanket gas, or early signs of thermal cracking. Suggest venting off light ends from fluid.
