System mornation	Sample information
Cenovus Sand Creek	System Volume: 25000 ltr	Lab No: 02227703
5023 54A Ave	Bulk Operating Temp: 455F / 235C	Analyst: Terry Veenstra
Eckville, AB T0M 0X0 Canada	Heating Source:	Sample Date: 07/03/18
Attn: Brendon Emmett	Blanket:	Received Date: 07/12/18
Tel: (780)898-7136	Fluid: PETRO CANADA PETRO-THERM	Completed: 07/17/18
E-Mail: brendon.emmett@cenovus.com	Make: BOURE CANADA	To discuss this report contact Terry
		Veenstra at (780)591-5339

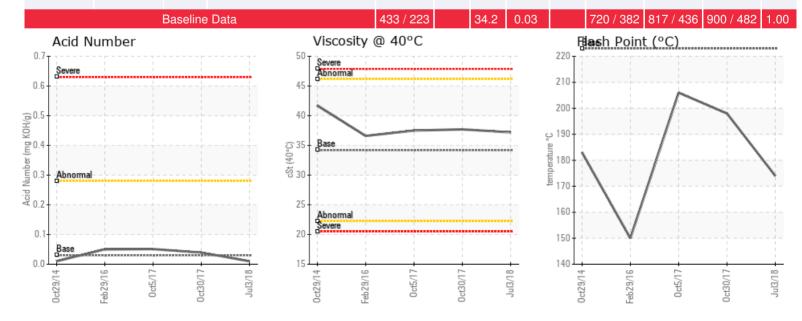
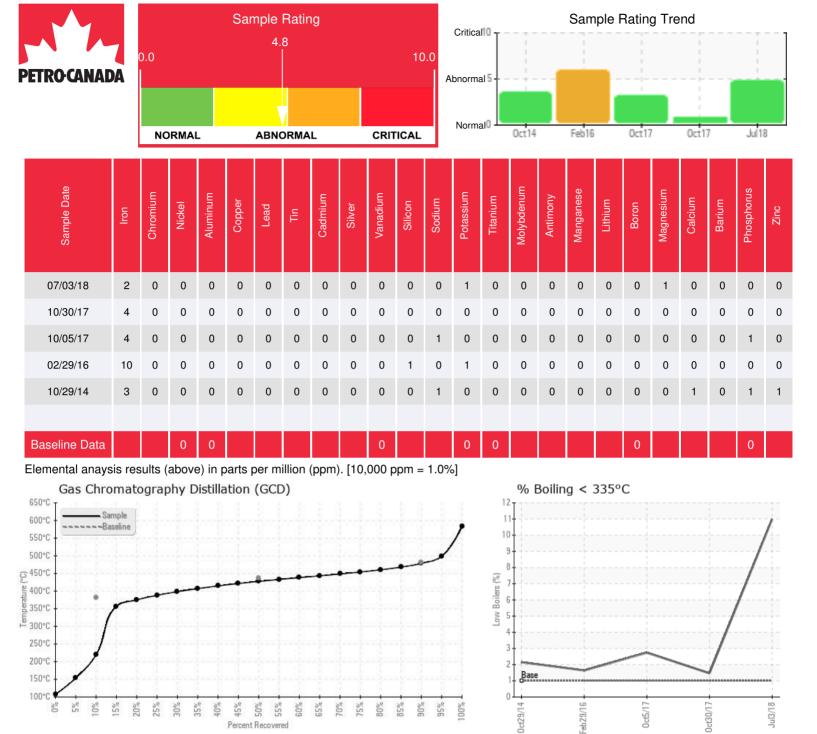
Recommendation: GCD @ 10% is abnormally low indicating some and COC Flash Point is abnormally low indicating thermal degradation of fluid. If a Natural Blanket instead of a Nitrogen Blanket is on place, this could be contributing to the Low boilers in the sample. GCD % <335°C is very high at 10.99%. Normally for Petrotherm, this should be ~1%. This could cause problems in low pressures areas such as the suction of the pumps. Recommendation: Vent off low boilers to atmosphere in safe manner and resample afterwards.

Comments: (GCD) 10% Distillation Point is severely low. COC Flash Point is abnormally low. (GCD) % < 335°C is marginally high.
