LINE 2

Customer: PTRHTF20031	System Information	Sample Information
MCCAIN FOODS PORTAGE PO BOX 220 1 McCain Avenue PORTAGE LA PRARIE, MB R1N 3B5 Canada Attn: Mark Nelissen Tel: x:	System Volume: 62000 ltr Bulk Operating Temp: 540F / 282C Heating Source: Blanket: Fluid: PETRO CANADA PETRO-THERM Make: VOLCANO	Lab No: 02233911 Analyst: Yutong Gao Sample Date: 08/12/18 Received Date: 08/15/18 Completed: 08/29/18 To discuss this report contact Yutong Gao at (403)873-1876

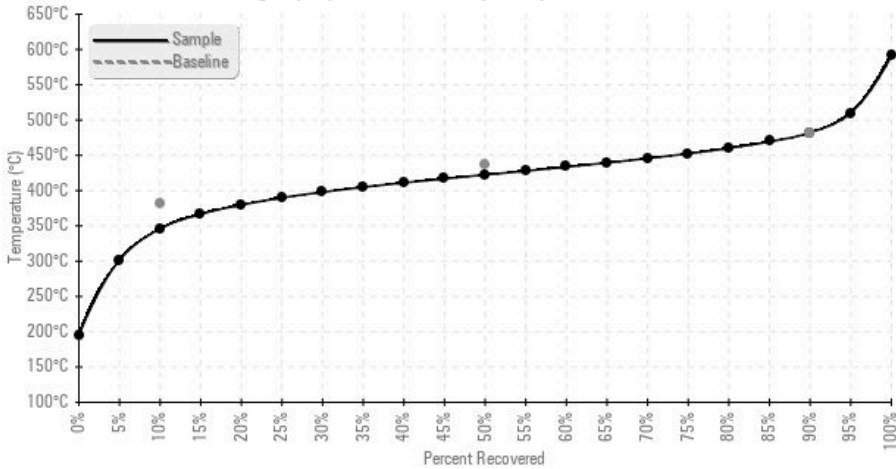
Gas Chromatography Distillation (GCD)

Comments: COC Flash Point is severely low. (GCD) % < 335°C is marginally high. (GCD) 10% Distillation Point is marginally low.

Recommendation: The current fluid has improved flash point, viscosity, and the distillation points. However, the fluid still has high content of the low boiler due to the thermal cracking at the 285 C bulk working temperature. Please continue to conduct the routine system venting and take one sample in 6 months to monitor the conditions.
