## **RELUTHERM RTAG-14**

Customer: PTRHTF40043	System Information	Sample Information
MORA PRODUCTIE BV	System Volume: 10000 ltr	Lab No: 02236313
FREGATWEG 53	Bulk Operating Temp: 275F / 135C	Analyst: Philip Riley
MAASTRICHT 6222NZ	Heating Source:	Sample Date: 08/23/18
MAASTRICHT, 6222NZ Netherlands	Blanket:	Received Date: 08/28/18
Attn: WILBERT SNIJERS	Fluid: PETRO CANADA PURITY FG HEAT TRANSFER FLUID	Completed: 08/31/18
Tel:	Make: RELUTHERM	To discuss this report contact Philip Riley
E-Mail: w.snijers@klt.nl		at (440)124-4378171

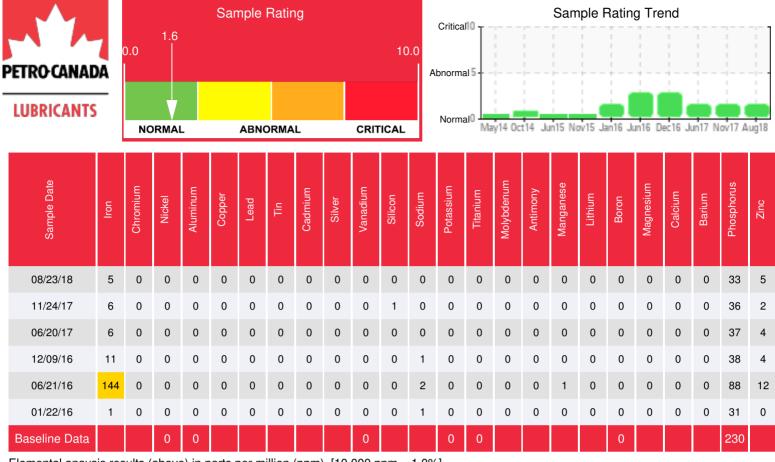
Elemental anaysis results (above) in parts per million (ppm). [10,000 ppm = 1.0%]

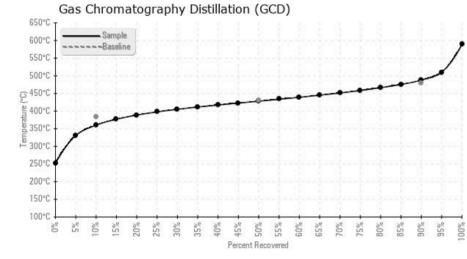
% Boiling < 335°C

Recommendation: Flash Point (COC) continued decline to a point at which the fluid needs to be changed. The GCD shows increased number of light molecules also supporting this. If the system can be safely vented then it may prolong the service life by raised the flash point. If it cannot then the fluid should be changed
