[13-25-80-16-W6M] H-5500-1 - Train 1

Customer: PTRHTF20156	System Information	Sample Information
TOURMALINE OIL 9920 98a Ave FORT ST. JOHN, BC V1J 1S2 Canada Attn: Brandon Braun Tel: (250)262-5420 E-Mail: Brandon.braun@tourmalineoil.com	System Volume: 40000 ltr Bulk Operating Temp: 464F / 240C Heating Source: Blanket: Fluid: PETRO CANADA PETRO-THERM Make: PROPAK	Lab No: 02237096 Analyst: Bill Quesnel CLS,OMA II,MLA-III,LLA-I Sample Date: 08/12/18 Received Date: 08/31/18 Completed: 08/12/20 Bill Quesnel CLS,OMA II,MLA-III,LLA-I

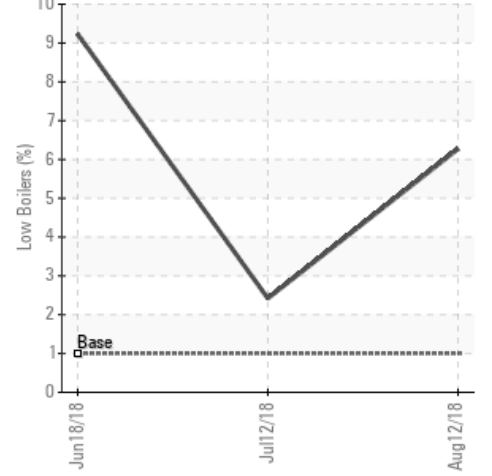
% Boiling < 335°C

Recommendation: Flash Point is severely low. Low flash point is a safety concern. % boil-off has increased to 6.27% from 2.42%. This may be attributed to either the condensate contamination and/or thermal degradation. This should be less than 1. Viscosity remains low; currently at 25 cSt vs 34 cSt of new fluid. Consider fluid replacement as the safest method to bring flash point back to acceptable values. Re-sample once fluid has been restored.
