RETURN CARGILL MEAT THAILAND

Customer: PTRHTF60010	System Information	Sample Information
SYNLUBE INTERNATIONAL CO LTD 76/1 MOO.7 THACHIN MUANG SAMUTSAKHON, 74000 THAILAND Attn: CHERNPORN CHOBKUI Tel: 034421290 E-Mail: chernporn@synlube.co.th	System Volume: 20910 ltr Bulk Operating Temp: 554F / 290C Heating Source: Blanket: Fluid: PETRO CANADA PURITY FG HEAT TRANSFER FLUID Make: WANSON	Lab No: 02237431 Analyst: Yutong Gao Sample Date: 08/25/18 Received Date: 09/05/18 Completed: 09/07/18 To discuss this report contact Yutong Gao at (403)873-1876

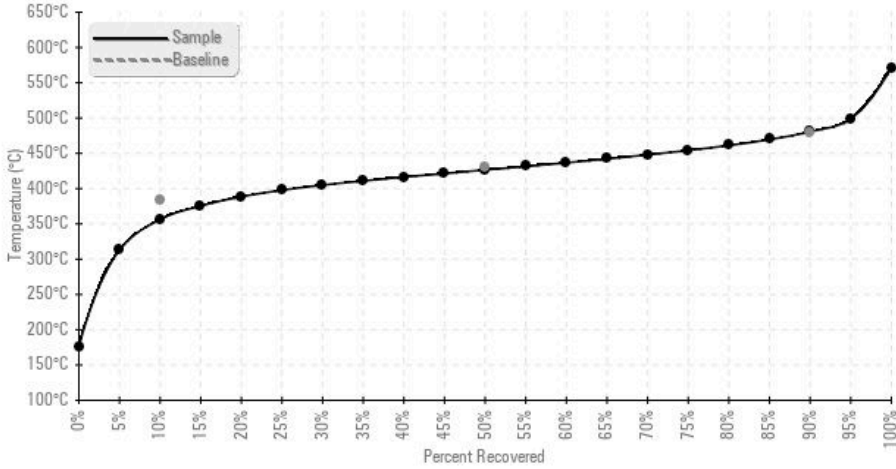
Gas Chromatography Distillation (GCD)

Recommendation: The current fluid conditions are very similar to the last sample in May. There are minimum third party contaminations such as water or dirty. The acid number and solid contents are very low, meaning minimum oxidation. The flash point is considered low due to thermal cracking at ~290C bulk working temperature. Please continue to do the system venting as a routine maintenance schedule. Please take one sample in 6 months to monitor the conditions.

05/23/18	The currently fluid has experienced severe thermal cracking at the extremely high bulk working temperature. However, the fluid flash point is higher than the previous three used oil samples, so the overall fluid conditions are improving. Please continue to do the effective system venting and take one sample in 6 months to monitor the conditions. COC Flash Point is abnormally low.
02/04/18	The current fluid has normal distillation points, the acid number and solid contents are all very low. However, the flash point is still much lower than the fresh fluid due to the thermal cracking at the extremely high bulk working temperature. Please do a long and effective system venting and take one sample in 6 months to monitor the conditions. COC Flash Point is severely low.
11/01/17	The current fluid has very low acid number, normal distillation point, and minimum water and solid particles. However, the viscosity and flash point are still much lower than the fresh fluid due to the thermal cracking at 290C bulk temperature. The flash point is higher than the last sample on Oct 13th, so please continue to do the effective system venting, and take one sample in 4 months to verify the conditions.
