WANSON EPC 2500 ES

Customer: PTRHTF40020	System Information	Sample Information
LE DUC FINE FOOD BV	System Volume: 1500 ltr	Lab No: 02243237
MEESTER SNIJDERWEG 18	Bulk Operating Temp: 265F / 129C	Analyst: Philip Riley
ZUID-HOLLAND	Heating Source:	Sample Date: 09/28/18
STELLENDAM, ZUI NETHERLANDS	Blanket:	Received Date: 10/04/18
Attn: Wilbert Snijers	Fluid: PETRO CANADA PURITY FG HEAT TRANSFER FLUID	Completed: 10/05/18
Tel:	Make: WANSON	To discuss this report contact Philip Riley
E-Mail: w.snijers@klt.nl		at (440)124-4378171

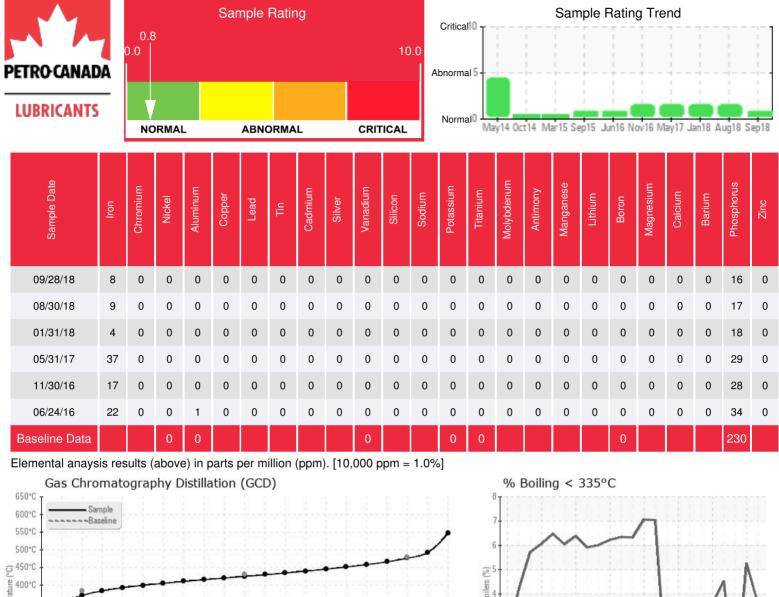
Recommendation: Looks to have been changed from previous sample. COC Flash Point already low and if safe to do so recommend venting system if possible to remove light molecules that have potentially brought flash point down. All other parameters within allowable limits.

Comments: COC Flash Point is abnormally low.
