RELUTHERM RTAG-14

Customer: PTRHTF40043	System Information	Sample Information
MORA PRODUCTIE BV	System Volume: 10000 ltr	Lab No: 02244128
FREGATWEG 53	Bulk Operating Temp: 275F / 135C	Analyst: Philip Riley
MAASTRICHT 6222NZ	Heating Source:	Sample Date: 10/02/18
MAASTRICHT, 6222NZ Netherlands	Blanket:	Received Date: 10/10/18
Attn: WILBERT SNIJERS	Fluid: PETRO CANADA PURITY FG HEAT TRANSFER FLUID	Completed: 10/12/18
Tel:	Make: RELUTHERM	To discuss this report contact Philip Riley
E-Mail: w.snijers@klt.nl		at (440)124-4378171

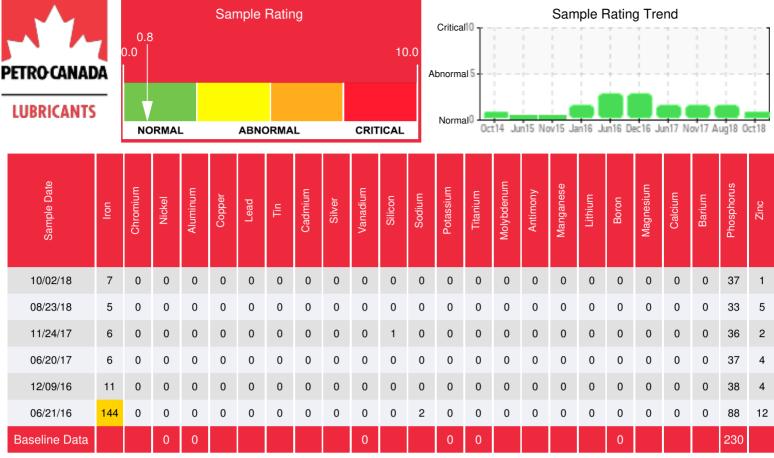
Elemental anaysis results (above) in parts per million (ppm). [10,000 ppm = 1.0%]

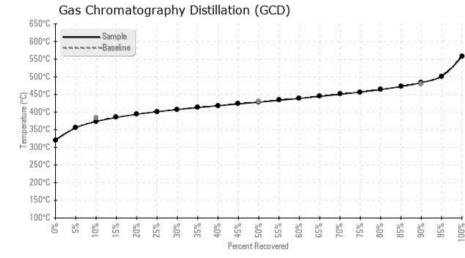
% Boiling < 335°C

Recommendation: Looks to have undergone some system/fluid maintenance since last sample 12 months ago. The fluid has recovered but could still benefit a little venting to drive off any light ends. Evidence of some fluid cracking on the trace but with correct venting, if safe to do so, COC Flash point should further recover.
