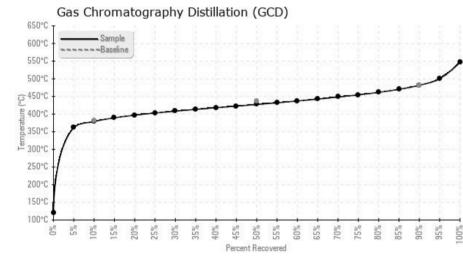
% Boiling < 335°C

02/28/18	Sample results indicate that the fluid is suitable for continued service and has improved since last sample as both water and total Acid Number have reduced significantly. The percentage boil off <335C has increased from 0.75 to 1.46 and there has been a slight reduction in flash point. This can indicate possible thermal degradation or contamination. Consider regular venting of the expansion tank after which time the blanket gas is turned back on. Re-sample in 6-12 months.
10/12/17	Water contamination can be a result of the expansion tank being exposed to precipitation. Slight increase in silicon (dirt/dust) may support this. Ensure points of ingression are sealed. Also confirm that sample was not drawn from a dead leg. Please always ensure a thorough purge before drawing sample. Allow water to boil off from expansion tank before putting blanket gas back into use. Aside from the water level in the oil, sample results indicate that the fluid is fit for continued service. Once water contamination has been vented and resolved, re-sample system in 6 months. Water contamination levels are severely high.
