UNIT A

Customer: PTRHTF30035	System Information	Sample Information
VEOLIA WATER 9 LESLIE STREET TORONTO, ON M4M 3M9 CANADA Attn: MICHAEL VULJICIC Tel: (416)406-0801 E-Mail: michael.vujicic@veoliawaterna.com	System Volume: 6000 ltr Bulk Operating Temp: 280F / 138C Heating Source: Blanket: Fluid: PETRO CANADA CALFLO HTF Make:	Lab No: 02252512 Analyst: Behshad Sabah Sample Date: 11/19/18 Received Date: 11/20/18 Completed: 11/26/18

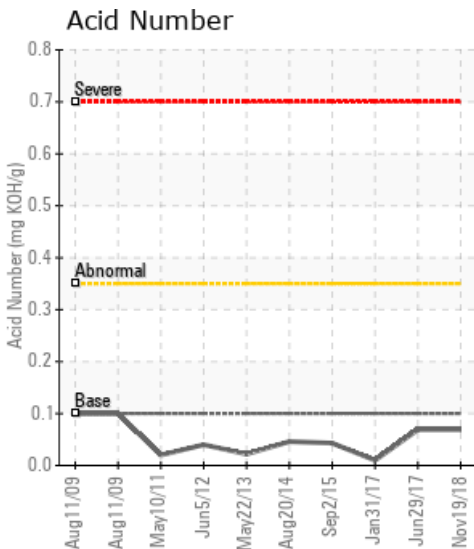
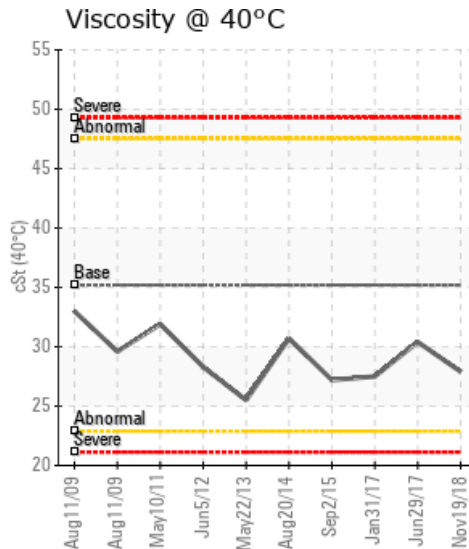
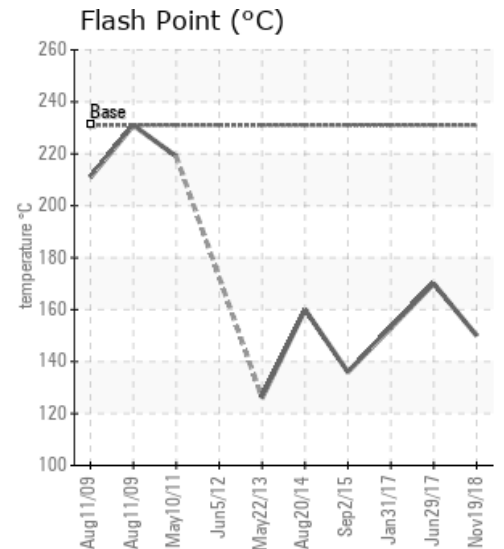
Comments: The oil is about 10 years old based on 2017 report. The low flash point indicates the degradation of the fluid and braking down the hydrocarbon chains to smaller ones. Your operating temperature is 280 F or 138 C. the open cup flash point is 150 C. These numbers getting very close. It will be a fire hazard if there is a leak into the open air. Acid number is very low which indicates there is not corrosion happening in the system. Have you added fresh oil to the system during 2018? It seems that you did add some oil in Q2 2017 but nothing during the 2018. (GCD) 10% Distillation Point is severely low. (GCD) 90% Distillation Point is severely low. COC Flash Point is severely low. (GCD) % < 335°C is abnormally high. (GCD) 50% Distillation Point is abnormally low.
