RETURN CARGILL MEAT THAILAND

Customer: PTRHTF60010	System Information	Sample Information
SYNLUBE INTERNATIONAL CO LTD 76/1 MOO.7 THACHIN MUANG SAMUTSAKHON, 74000 THAILAND Attn: CHERNPORN CHOBKUI Tel: 034421290 E-Mail: chernporn@synlube.co.th	System Volume: 20910 ltr Bulk Operating Temp: 554F / 290C Heating Source: Blanket: Fluid: PETRO CANADA PURITY FG HEAT TRANSFER FLUID Make: WANSON	Lab No: 02253874 Analyst: Yutong Gao Sample Date: 11/17/18 Received Date: 11/27/18 Completed: 12/05/18

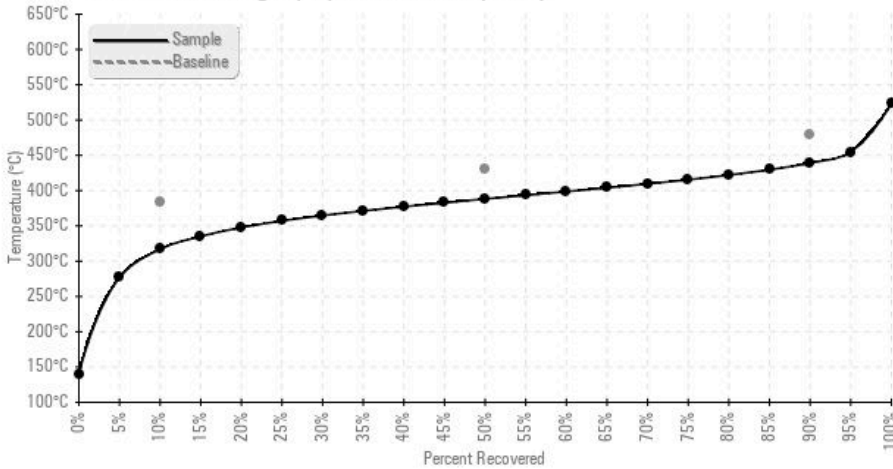
Gas Chromatography Distillation (GCD)

Comments: (GCD) 10% Distillation Point is severely low. (GCD) 90% Distillation Point is severely low. COC Flash Point is severely low. (GCD) % < 335°C is abnormally high. (GCD) 50% Distillation Point is abnormally low.

Recommendation: The current fluid has low viscosity, low flash point due to the severe thermal cracking at high bulk working temperature. Please conduct the effective system venting to release the low boiler. The acid number and solid content are all very low indicating minimum oxidation and minimum system deposit. Please take one sample in 4 months to monitor the conditions.
