## [13-25-80-16-W6M] TRAIN #1 HEAT MEDIUM

Customer: PTRHTF20156	System Information	Sample Information
TOURMALINE OIL 13-25-80-16W6 9920 98a Ave FORT ST. JOHN, BC V1J 1S2 Canada Attn: Brandon Braun Tel: (250)262-5420 E-Mail:	System Volume: 40000 ltr Bulk Operating Temp: 388F / 198C Heating Source: Blanket: Fluid: PETRO CANADA PETRO-THERM Make: PROPAK	Lab No: 02258128 Analyst: Peter Hartevelde Sample Date: 12/01/18 Received Date: 12/18/18 Completed: 12/21/18

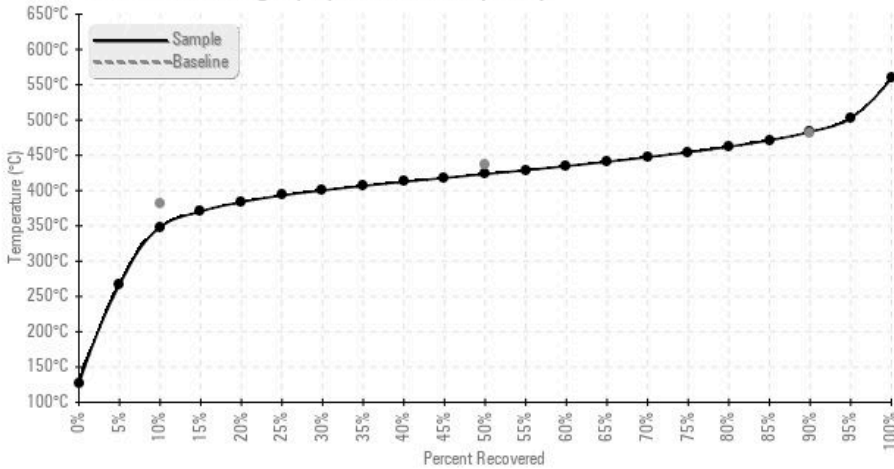
### Gas Chromatography Distillation (GCD)

Comments: COC Flash Point is severely low. (GCD) % < 335°C is marginally high. (GCD) 10% Distillation Point is marginally low.

Recommendation: The fluid is in a reasonable condition and suitable for further use but there are indications of either thermal degradation, blanket gas ingress or, considering previous analysis results, indications of an internal process fluid leak. Viscosity, Flash Point and GCD 10% temperature are low. % boil-off below 335 degrees C is high. If an internal process fluid leak is suspect this has to be corrected. In any case it is recommended to vent off the low boiler vapors (light ends) to atmosphere. Please re-sample in 6 months.
