## [13-25-80-16-W6M] H-5500-1 - Train 1

Customer: PTRHTF20156	System Information	Sample Information
TOURMALINE OIL 9920 98a Ave FORT ST. JOHN, BC V1J 1S2 Canada Attn: Brandon Braun Tel: (250)262-5420 E-Mail: Brandon.braun@tourmalineoil.com	System Volume: 40000 ltr Bulk Operating Temp: 464F / 240C Heating Source: Blanket: Fluid: PETRO CANADA PETRO-THERM Make: PROPAK	Lab No: 02258128 Analyst: Bill Quesnel CLS,OMA II,MLA-III,LLA-I Sample Date: 12/01/18 Received Date: 12/18/18 Completed: 08/12/20 Bill Quesnel CLS,OMA II,MLA-III,LLA-I

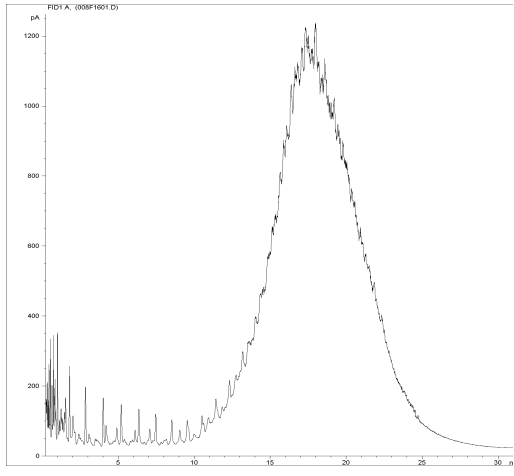
GCD Spectrum

**Comments:** COC Flash Point is severely low. (GCD) % < 335°C is marginally high. (GCD) 10% Distillation Point is marginally low.

**Recommendation:** The fluid is in a reasonable condition and suitable for further use but there are indications of either thermal degradation, blanket gas ingress or, considering previous analysis results, indications of an internal process fluid leak. Viscosity, Flash Point and GCD 10% temperature are low. % boil-off below 335 degrees C is high. If an internal process fluid leak is suspect this has to be corrected. In any case it is recommended to vent off the low boiler vapors (light ends) to atmosphere. Please resample in 6 months.

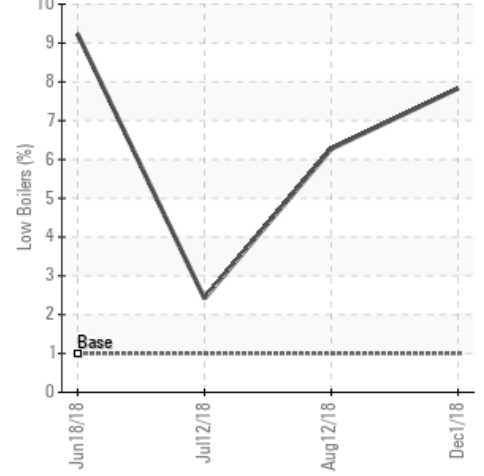
% Boiling < 335°C

08/12/18	Flash Point is severely low. Low flash point is a safety concern. % boil-off has increased to 6.27% from 2.42%. This may be attributed to either the condensate contamination and/or thermal degradation. This should be less than 1. Viscosity remains low; currently at 25 cSt vs 34 cSt of new fluid. Consider fluid replacement as the safest method to bring flash point back to acceptable values. Re-sample once fluid has been restored.
07/12/18	Sample results indicate that the fluid has a very low flash point (100C). This can be a safety risk. There is some improvement since the last sample in flash point and distillation values, however, AN has increased. If venting has been occurring since the last sample, exposing the fluid to air can increase acidity via oxidation. Consider fluid replacement as the safest method to bring flash point back to acceptable values. Re-sample once fluid has been restored. COC Flash Point is severely low.
