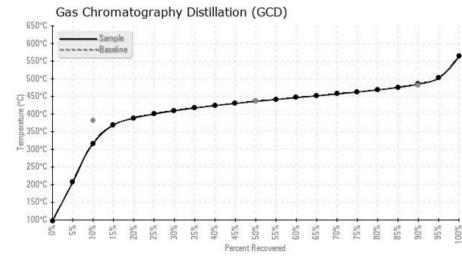
## % Boiling < 335°C

Comments: (GCD) 10% Distillation Point is severely low. COC Flash Point is severely low. (GCD) % < 335°C is marginally high.

Recommendation: GDC 10% Distillation as well has the Flash Point are low indicating some lighter ends. Venting of the system is required. Vent lighter ends off system and resample in 6 months.
