## FREMONT RPG

Customer: PTRHTF10036	System Information	Sample Information
CERTAITEED - SAINT GOBAIN 6400 STEVENSON BLVD FREMONT, CA 94538-2468 USA Attn: Dan Arata Tel: (510)490-0890 E-Mail: dan.d.arata@saint-gobain.com	System Volume: 5000 gal Bulk Operating Temp: 450F / 232C Heating Source: Blanket: Fluid: PETRO CANADA CALFLO HTF Make: FIRST THERMAL	Lab No: 02270622 Analyst: Steven Slanker Sample Date: 02/16/19 Received Date: 02/28/19 Completed: 03/04/19

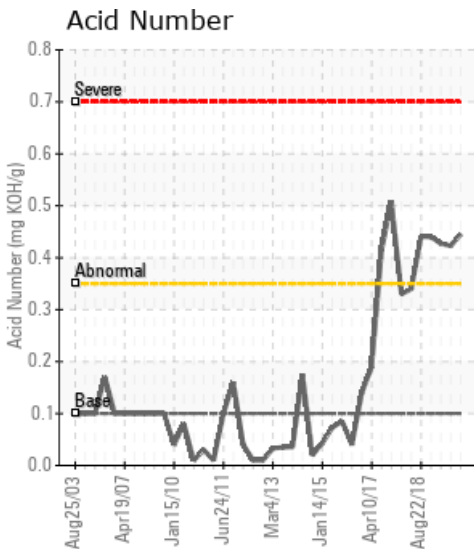
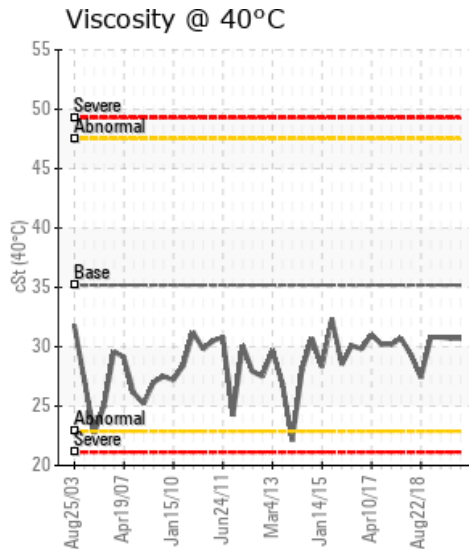
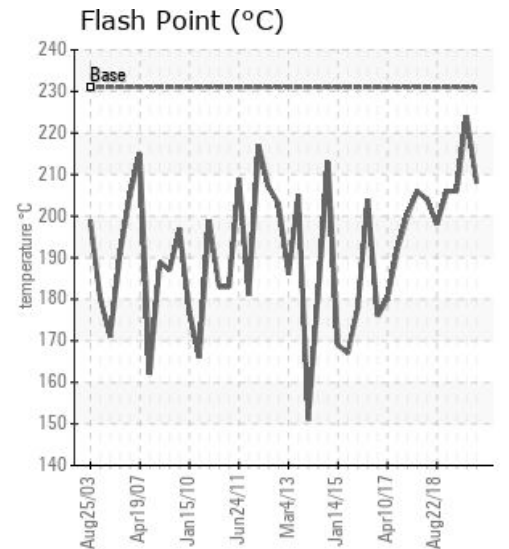
Comments: Acid Number (AN) is abnormally high. (GCD) 90% Distillation Point is marginally low.

Recommendation: The Acid Number has been relatively stable over the last 6 months but shows oxidation has occurred. The oil won't degrade rapidly but it's better to adopt a proactive approach. If left to degrade until it fouls the system, it will force a full system cleaning and flushing. If you have a shut-down in the coming months, we would advise to consider replacing a portion (example 30 - 50%) of the fluid with fresh Calflo to maintain healthy oil.
