GFPT-FURTHER#1#2

| Customer: PTRHTF60010 | System Information | Sample Information |
|---|---|---|
| SYNLUBE INTERNATIONAL CO LTD | System Volume: 7000 ltr | Lab No: 02271407 |
| Attn: CHERNPORN CHOBKUI | Fluid: PETRO CANADA PURITY FG HEAT TRANSFER FLUID | Completed: 03/06/19 |
| Tel: 034421290 | Make: WANSON | |

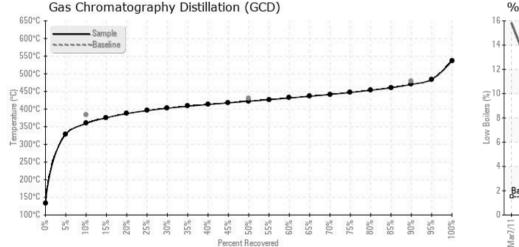
% Boiling < 335°C

Recommendation: The current fluid has normal viscosity and distillation point. The acid number, solid content and the contaminants are all low. The flash point is lower than the fresh oil, but still acceptable. Please continue to run the oil and take one sample in 12 months to monitor the conditions.
