# **CARGILL MEAT**

### Customer: PTRHTF60010

Fluid: PETRO CANADA PURITY FG HEAT TRANSFER FLUID

Lab No: 02271408 Analyst: Yutong Gao Sample Date: 02/20/19 Received Date: 03/05/19 Completed: 03/07/19

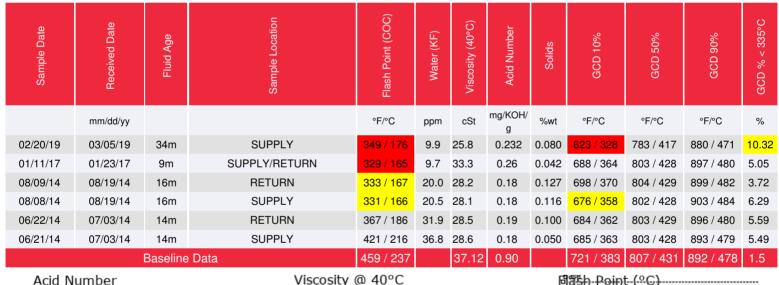
Comments: (GCD) 10% Distillation Point is low. COC Flash Point is low. (GCD) % < 335°C is high.

Recommendation: The current fluid has minimum oxidation, very low solid contents and very low third party contaminants such as the water and dirt particles. The oil viscosity and flash point are all lower than the fresh oil mainly due to the thermal cracking at high bulk temperature conditions. Please plan and conduct the system venting as soon as possible. Please run the current fluid and take one sample in 6 months to monitor the conditions.

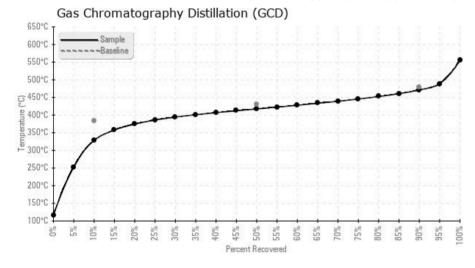
Please confirm where this sample was taken from? The test results indicate the oil has decent viscosity, TAN, Solid content and the GCD points. However, the flash point is very low due to the thermal cracking. The low boiler of the fluid needs to be vented from the system as soon as possible. Please confirm if the 01/11/17 system was modified to allow the efficient venting. Please also confirm what is the AIT test result to address the safety concerns. The fluid should be well mixed, the return/supply lines have very similar test results interm of viscosity/flash point/particles. However, there is noticable difference on GCD%<335C and GCD 10%. The sulfur level is 43ppm (don't include in the report) indicates there might be a third party contamination. Most likely, this is also a bad 08/09/14 sample. Please make sure there is no change of the venting process and take a good sample after a longer period of flushing. COC Flash Point is marginally low. If the current venting process is still the same (~ 200L oil topup/month), there is no reason to see the flash point drop from 186C to 166C within 2 months. The sulfur level is 40ppm (don't include in the report) indicates there might be a third party contamination. Most likely, this is a bad sample. Please make sure there is no change 08/08/14 of the venting process and take a good sample after a longer period of flushing. COC Flash Point is marginally low. (GCD) 10% Distillation Point is marginally low. Viscosity, GCD distillation, Flash Points and Solid level are all good. However, the flash point reading is still lower than the supply line sample, looks like the fluid is not well mixed. Please take one sample in 4 months to monitor. 06/22/14 Viscosity, GCD distillation, Flash Points and Solid level are all good. Please take one sample in 4 months to monitor. 06/21/14
