[16-11-54-15W5] BONAVISTA

BONAVISTA ENERGY 16-11-54-15-W5

System Information

Sample Information

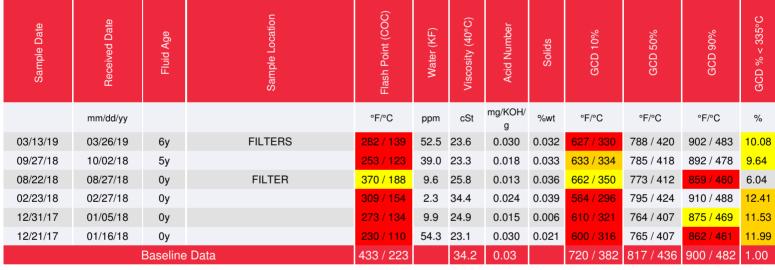
Comments: (GCD) 10% Distillation Point is severely low. COC Flash Point is severely low. (GCD) % < 335°C is marginally high.

Recommendation: The condition of the fluid is similar to what it was in September of 2018. Low boiler vapor content is high, Flash Point low, 10% GCD temperature is low. All of these indicate the fluid is not degassing properly. The fluid is suitable for further use but to prevent pump cavitation or flow stagnation problems from happening it would be good to do a thorough venting of vapor. Perhaps this can take place prior to a facility maintenance turnaround. Please re-sample after venting.

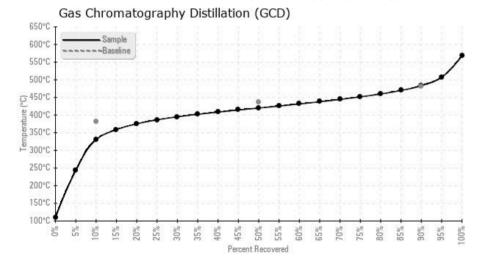
The fluid is in a reasonable condition and suitable for further use but the analysis results reflect either increased thermal degradation of the fluid or ineffective degassing via system modification. The Flash Point is low and a safety concern in case an external leak occurs. The low boiler vapor content has increased and 10% GCD temperature has decreased. A vapor content of 9.6% may cause cavitation problems at the suction side of the heat medium pumps. The vapor has to be vented off. Also check if this condition can be caused by an internal leak of process fluid into the Petro-Therm. COC Flash Point is severely low. (GCD) 10% Distillation Point is abnormally low. (GCD) % < 335°C is marginally high.

The fluid is in good condition and suitable for further use. The modifications made to allow for continuous de-gassing of the fluid have resulted in improvements in Flash Point, low boiler vapor content (%-335C went from 12.41% to 6.04%) and 10% GCD temperature. The 90% GCD temperature and viscosity have decreased. This can be the result of low boiler vapor ingress. (low boiler vapor content of fresh Petro-Therm is 1% and is currently still elevated at 6.04%). The advise is to keep operating the system this way with close monitoring of the de-gassing vessel pressure and take a sample in 6 months. Please list the service life of the fluid on the analysis request form. (GCD) 90% Distillation Point is severely low. COC Flash Point is marginally low. (GCD) 10% Distillation Point is marginally low.

The fluid is in a reasonable condition and suitable for further use. There is a small improvement in Flash Point, viscosity and top-end of the distillation curve. The low boiler vapor content is still too high. Please keep venting on a regular basis and re-sample in 3 months time. (May/June) Please list the fluid age on the next analysis request form. (GCD) 10% Distillation Point is severely low. COC Flash Point is severely low. (GCD) % < 335°C is abnormally high.

This sample was taken two weeks after the previous one. The fluid shows an increase in thermal degradation. If the sample was taken from a different sample point or there is an internal leak of process fluid into the Petro-Therm it would explain the ongoing degradation. The combination of low viscosity, low Plash Point, high % boil-off below 335C and low 10% GCD temperature indicate thermal degradation but the same symptoms will show when there is an internal leak. Venting of low boiler vapors to atmosphere is still recommended to restore fluid condition. Currently the fluid is suitable for further use. (GCD) 10% Distillation Point is severely low. COC Flash Point is severely low. (GCD) % < 335°C is abnormally high. (GCD) 90% Distillation Point is marginally low.
