## WANSON EPC 2500 ES

Customer: PTRHTF40020	System Information	Sample Information
LE DUC FINE FOOD BV	System Volume: 1500 ltr	Lab No: 02281302
MEESTER SNIJDERWEG 18	Bulk Operating Temp: 265F / 129C	Analyst: Philip Riley
ZUID-HOLLAND	Heating Source:	Sample Date: 04/16/19
STELLENDAM, ZUI NETHERLANDS	Blanket:	Received Date: 04/24/19
Attn: Wilbert Snijers	Fluid: PETRO CANADA PURITY FG HEAT TRANSFER FLUID	Completed: 05/07/19
Tel:	Make: WANSON	
E-Mail: w.snijers@klt.nl

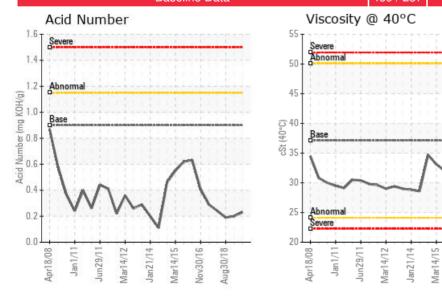
Flash Point (°C)

Comments: Iron ppm levels are noted. COC Flash Point is abnormally low.

09/28/18	Looks to have been changed from previous sample. COC Flash Point already low and if safe to do so recommend venting system if possible to remove light molecules that have potentially brought flash point down. All other parameters within allowable limits. COC Flash Point is abnormally low.
08/30/18	COC Flash Point is very low indeed. Viscosity is trending slightly downwards also. Recommend the fluid is changed COC Flash Point is severely low.
01/31/18	COC Flash Point significantly lower than expected, confirming also previous result. Looking at the GCD the system has potentially been vented, there look to be fewer light end molecules. This has however had no impact on the COC Flash Point. All other parameters look to be improved from previous result. As this is a repeat result of the previous flash point, primary recommendation is for a system change out including a flush COC Flash Point is severely low.

Recommendation: COC Flash Point trending downwards, and must show caution. If it can be recovered safely through any form of venting (although no great volume of light molecules look to be present) if would be worth doing to potentially extend the life of the fluid.

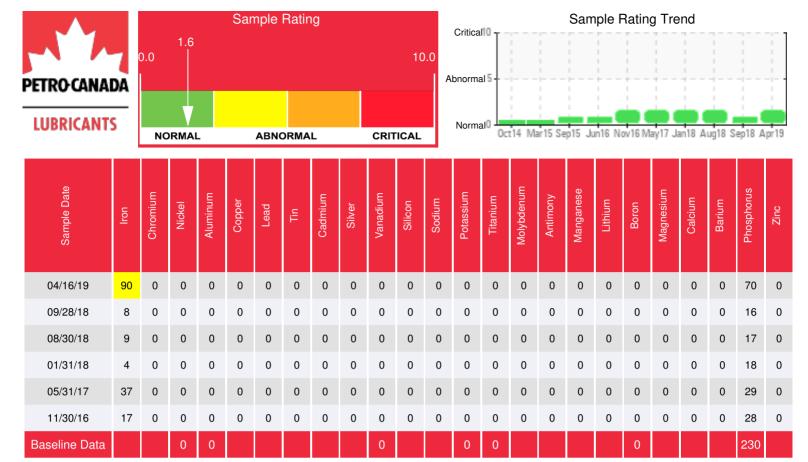
Elemental analysis results (above) in parts per million (ppm). [10,000 ppm = 1.0%]
