## RETURN CARGILL MEAT THAILAND

Customer: PTRHTF60010	System Information	Sample Information
SYNLUBE INTERNATIONAL CO LTD 76/1 MOO.7 THACHIN MUANG SAMUTSAKHON, 74000 THAILAND Attn: CHERNPORN CHOBKUI Tel: 034421290 E-Mail: chernporn@synlube.co.th	System Volume: 20910 ltr Bulk Operating Temp: 554F / 290C Heating Source: Blanket: Fluid: PETRO CANADA PURITY FG HEAT TRANSFER FLUID Make: WANSON	Lab No: 02283129 Analyst: Yutong Gao Sample Date: 04/26/19 Received Date: 05/03/19 Completed: 05/22/19

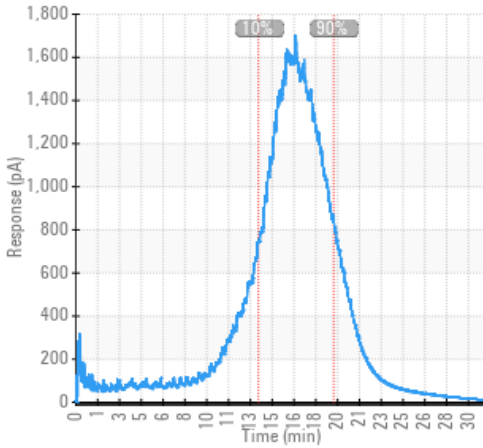
### GCD Spectrum

Recommendation: The current fluid has very low flash point and low viscosity at 40C because of the severe thermal cracking. The low boiler needs to be released by effective system venting. However the fluid distillation points are still adequate. Please confirm if the representative sample was taken at the plant? The sample needs to be taken at the sample place after the oil is well circulated. Please take one more sample and send to Focuslab and just do the viscosity and flash point tests to confirm. If the results are still low, please drain half of the system and fill the new fluid. If the system is dirty, please arrange the system cleaning and flushing.

Comments: COC Flash Point is severely low. (GCD) 10% Distillation Point is marginally low.
