TFS H/O SYSTEM #2

Customer: PTRHTF10176

CERTAINTEED ROOFING 100 CERTAINTEED DR JONESBURG, MO 63351 USA

Lab No: 02291773

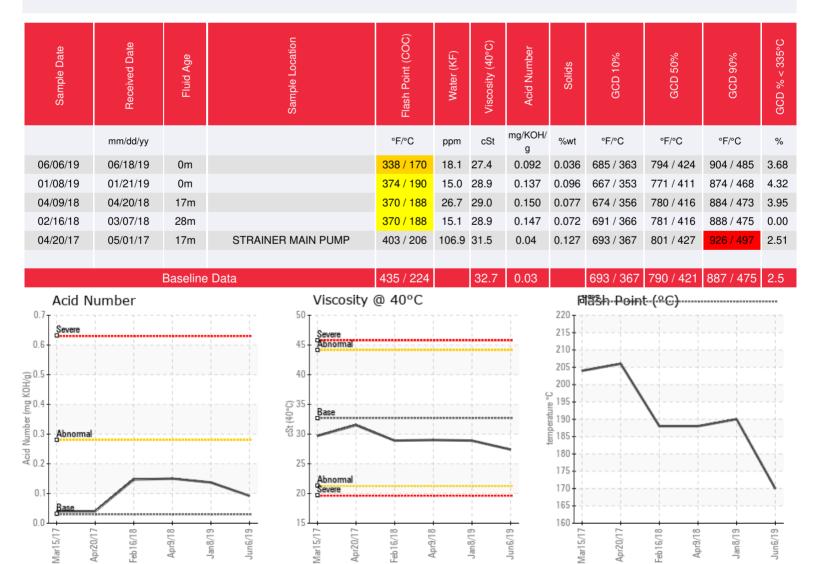
Comments: COC Flash Point is abnormally low.

Recommendation: The viscosity has been slowly declining and so is the flash point. We suggest to vent the low boilers and replace the volume lost by adding fresh oil in the expansion tank.
