[DAIBER A-54-C/94-B-16] STABILIZER REBOILER

KANATA ENERGY GROUP DAIBER GAS PLANT A-54-C/94-B-16 FORT ST. JOHN, BC V1J 0H8 Canada

Lab No: 02298380 Analyst: Clinton Buhler Sample Date: 07/21/19 Received Date: 07/22/19 Completed: 07/30/19

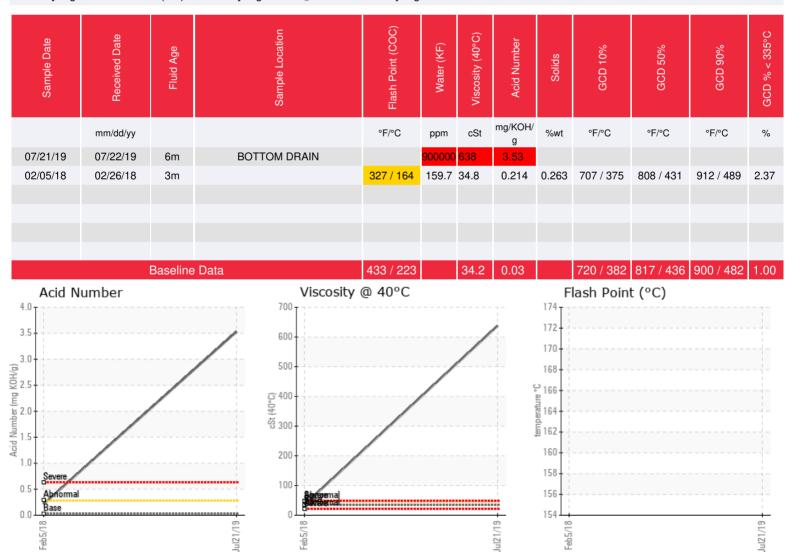
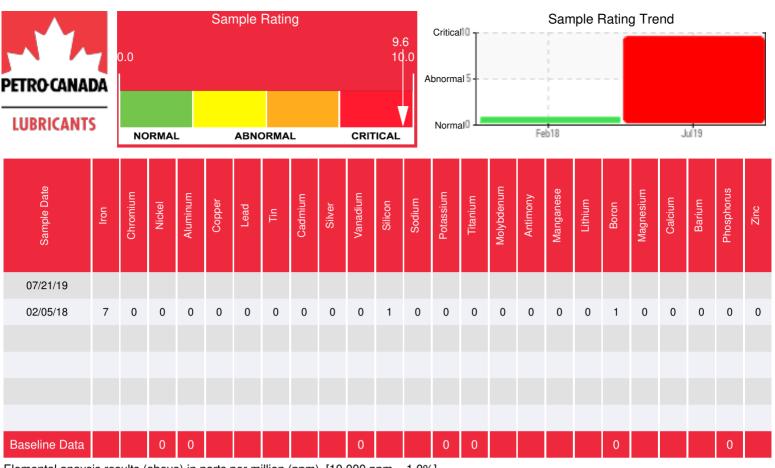
Comments: Water contamination levels are severely high. Water contamination levels are severely high. ppm Water contamination levels are severely high. Acid Number (AN) is severely high. Visc @ 40°C is severely high.

Elemental analysis results (above) in parts per million (ppm). [10,000 ppm = 1.0%]

Recommendation: *** Diagnostician`s Note: This sample is mostly water. Suggest the client drain off the water from the reservoir, then take a more representative sample. ***An immediate re-sample is required!Excess water in system. Please note that the fluid's acidity and viscosity is excessive and may not be representative. Please re-sample immediately. Please draw sample from most representative area of the heater vessel as possible. First drain all free water from system. Follow this by a purge of at least 20 liters of fluid until the fluid coming out is hot per normal operating temperatures. Collect sample and submit to the lab for analysis and Petro-Canada Technical Services will review and provide recommendations
