## **WANSON EPC 2500 ES**

## Customer: PTRHTF40020

LE DUC FINE FOOD BV MEESTER SNIJDERWEG 18

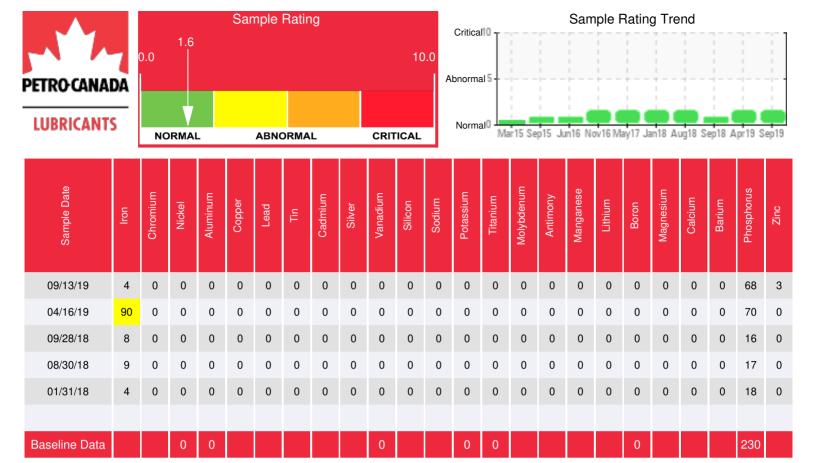
Comments: Pentane Insolubles levels are severely high.

Elemental analysis results (above) in parts per million (ppm). [10,000 ppm = 1.0%]

Recommendation: Was this an oil change? All parameters around Flash Point and viscosity seem to have recovered to normal levels, but the insoluble are very high. Try some filtration to remove insoluble matter and check at normal oil sample interval.
