## LINE 3 HOT OIL SYSTEM

## Customer: PTRHTF10069

CERTAINTEED - SAINT GOBAIN 3303 EAST 4TH AVENUE SHAKOPEE, MN 55379 USA

Lab No: 02315483

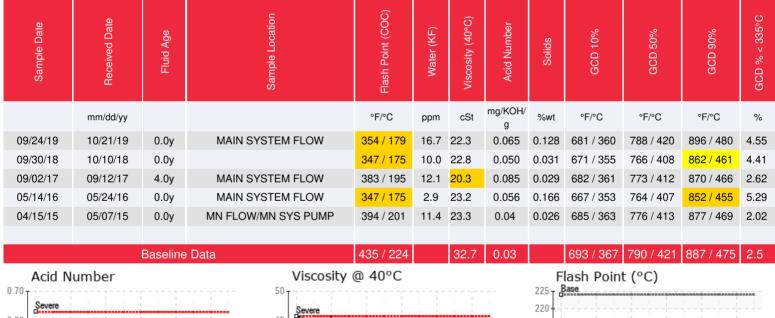
Recommendation: The oil is holding steady, although some properties like viscosity and flash point are flagged. This is likely due to the presence of Therminol 55 in this system when the computer compares to Calflo AF. Contamination by asphalt, water or other elements is insignificant or non-detectable. No actions needed at this time. Re-sample at next scheduled interval

Comments: COC Flash Point is abnormally low.

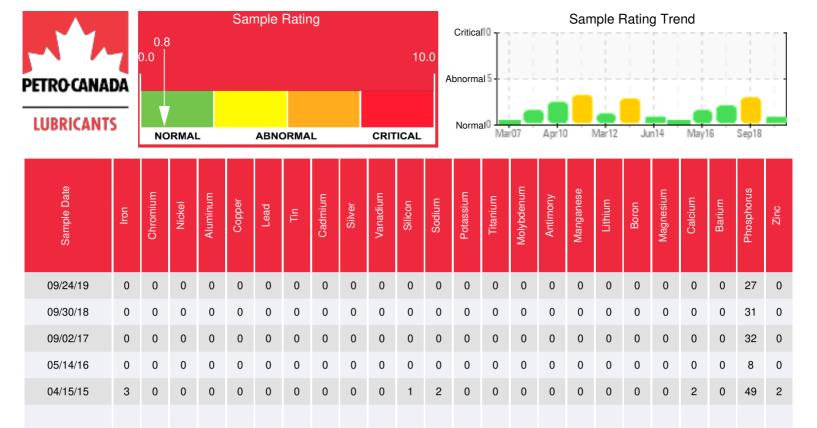
Elemental analysis results (above) in parts per million (ppm). [10,000 ppm = 1.0%]
