WANSON EPC 2500 ES

Customer: PTRHTF40020	System Information	Sample Information
LE DUC FINE FOOD BV	System Volume: 1500 ltr	Lab No: 02328630
MEESTER SNIJDERWEG 18	Bulk Operating Temp: 265F / 129C	Analyst: Philip Riley
ZUID-HOLLAND	Heating Source:	Sample Date: 10/12/19
STELLENDAM, ZUI NETHERLANDS	Blanket:	Received Date: 12/23/19
Attn: Wilbert Snijers	Fluid: PETRO CANADA PURITY FG HEAT TRANSFER FLUID	Completed: 01/12/20
Tel:	Make: WANSON	
E-Mail: w.snijers@klt.nl

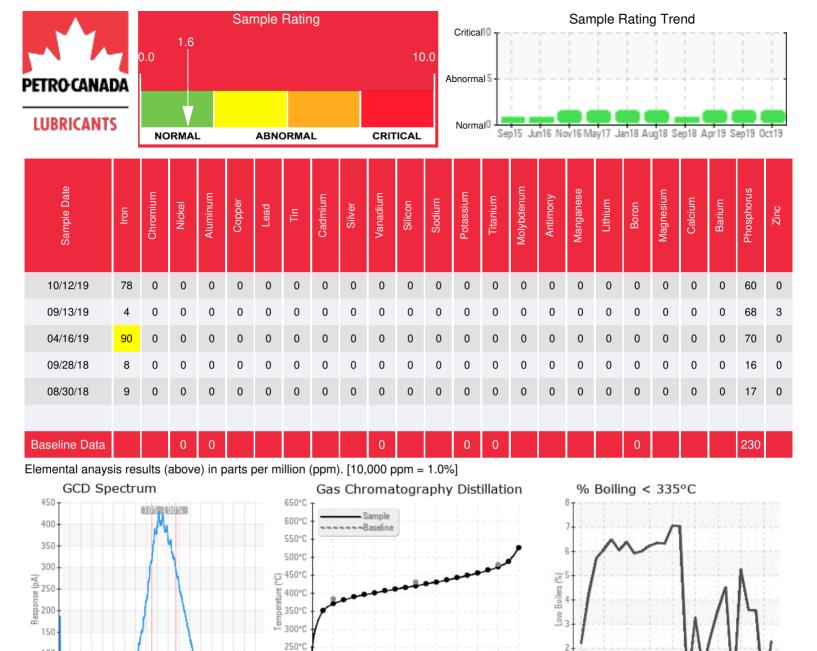
Recommendation: Going through the history of this sample it raises some concerns. In this current sample there has been a loss in viscosity of 10cSt from previous, and a significant drop in flash point to a level that is severely low. The curve shows a little evidence of cracking, but levels of low weight hydrocarbons look fairly low. SOme venting, if it can be done safely, may recover the flash point. I would attempt safe venting and re-sample. If it cannot be done a confirmation or another sample would be recommended as the step downwards in viscosity and flash point shows a worrying trend

Comments: COC Flash Point is severely low.
