[PROCESS HEATER PLTS 1 & 2 / LSD: 3-22-78-12W6] CL#1604-0442-02 BIRCHCLIFF

Sample Information

Lab No: 02331379 Analyst: Clinton Buhler Sample Date: 12/01/19 Received Date: 01/13/20 Completed: 01/15/20

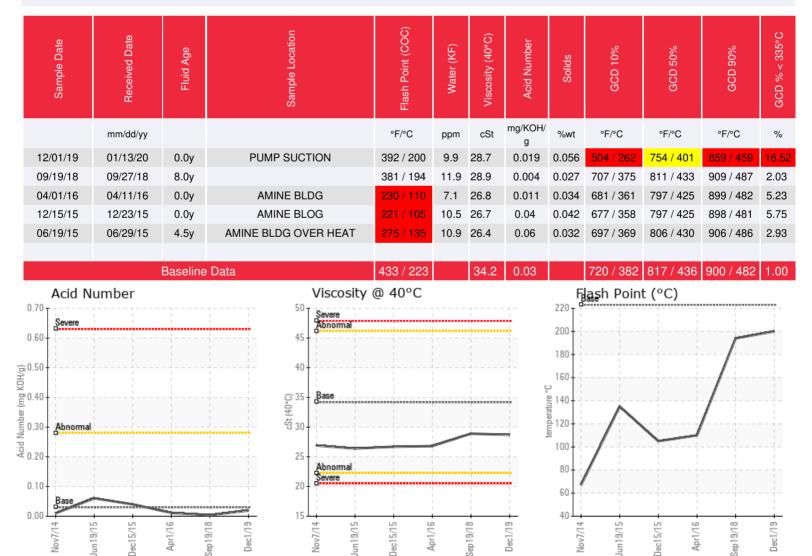
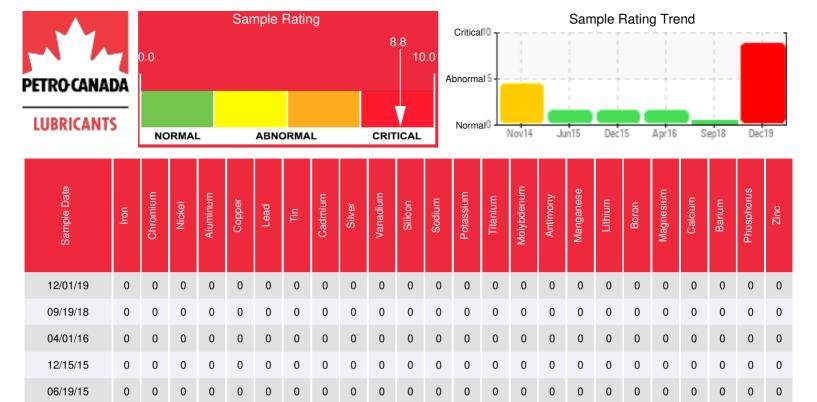
Recommendation: Sample results indicate that the fluid may be suitable for continued service. However, % boil-off of 16.52% and reduced 10% and 90% distillation temperatures is significant and may be an indication of thermal degradation, contaminants such as condensate or possibly a result of high blanket gas pressure. It is recommended to routinely vent off any low boiling vapors from the system on a regular basis. This may need to occur during an outage in the event the high blanket gas pressure is required for positive suction head pressure. Please re-sample fluid in 6 months after thorough venting has been performed.

Elemental analysis results (above) in parts per million (ppm). [10,000 ppm = 1.0%]

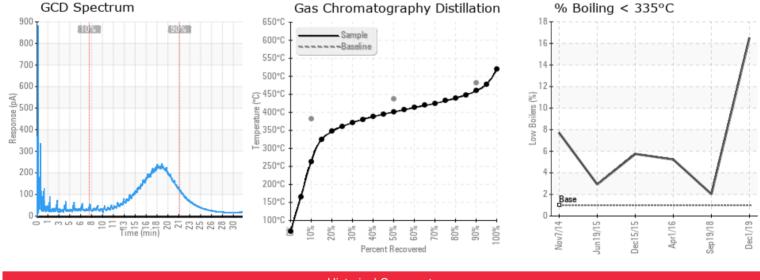
Baseline Data

Historical Comments	
09/19/18	Sample results indicate that the fluid is suitable for continued service. % boil-off of 2.03% and slightly reduced flashpoint may be an indication of thermal degradation or possibly a mixture of fluids. As a good preventative maintenance practice, it is ideal to vent off any low boiling vapors from the system on a regular basis.Re-sample fluid in 6 months to establish a trend
04/01/16	The flash point on this sample is extremely low as is the Viscosity. Check for leakage of condensate into heat transfer system. COC Flash Point is severely low.
	Flash point of samples is extremely low. Possibly contaminated with condensate. This would also be the reason the viscosity is so low versus new oil. COC Flash Point is severely low.
06/19/15	Flash point is still severly low although not as low as previous sample. GCD's have also improved. Resample again in 6 months. COC Flash Point is severely low.
