RETURN CARGILL MEAT THAILAND

Customer: PTRHTF60010	System Information	Sample Information
SYNLUBE INTERNATIONAL CO LTD 76/1 MOO.7 THACHIN MUANG SAMUTSAKHON, 74000 THAILAND Attn: CHERNPORN CHOBKUI Tel: 034421290 E-Mail: chernporn@synlube.co.th	System Volume: 11275 ltr Bulk Operating Temp: 554F / 290C Heating Source: Blanket: Fluid: PETRO CANADA PURITY FG HEAT TRANSFER FLUID Make: WANSON	Lab No: 02334959 Analyst: Philip Riley Sample Date: 01/14/20 Received Date: 01/30/20 Completed: 02/12/20 Philip Riley philip.riley@petrocanadalsp.com

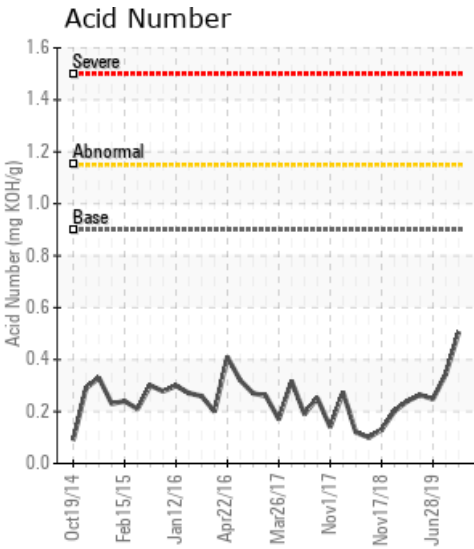
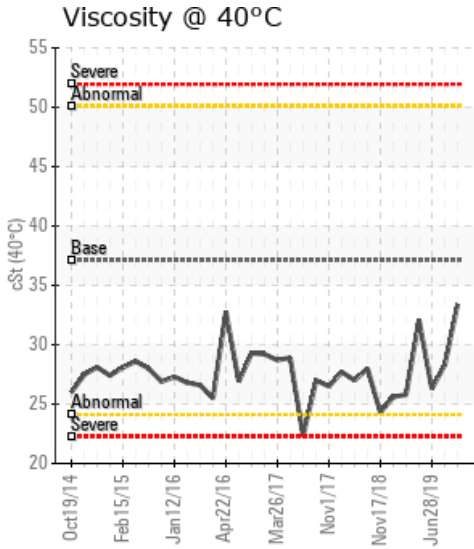
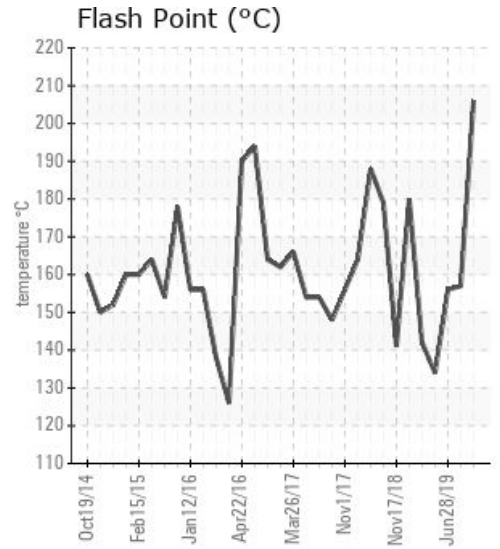
Comments: COC Flash Point is marginally low.

Sample Date	Received Date	Fluid Age	Sample Location	Flash Point (COC)	Water (KF)	Viscosity (40°C)	Acid Number	Solids	GCD 10%	GCD 50%	GCD 90%	GCD % < 335°C
	mm/dd/yy			°F/°C	ppm	cSt	mg/KOH/g	%wt	°F/°C	°F/°C	°F/°C	%
01/14/20	01/30/20	10d		403 / 206	2.2	33.4	0.505	0.058	725 / 385	807 / 431	896 / 480	0.00
10/12/19	10/25/19	42d	SUPPLY/RETURN	315 / 157	9.6	28.3	0.345	0.117	672 / 356	791 / 422	885 / 474	6.15
06/28/19	07/11/19	38d		313 / 156	28.1	26.3	0.248	0.027	677 / 359	794 / 423	885 / 474	5.71
06/02/19	06/11/19	38d		273 / 134	10.8	32.1	0.264	0.182	671 / 355	797 / 425	893 / 479	6.55
04/26/19	05/03/19	36d		288 / 142	8.0	25.8	0.240	0.049	664 / 351	798 / 426	895 / 479	7.38
Baseline Data				459 / 237		37.12	0.90		721 / 383	807 / 431	892 / 478	1.5

Recommendation: Flash point (COC) slightly low but within reasonable boundaries. If safe venting can take place to recover then look towards this after next analysis if it continues to reduce but currently fit for further use. All other parameters meet spec. Please re-sample at normal interval
