Recommendation: Sample results indicate that the fluid is suitable for continued service. Understanding that there has been ongoing pump mechanical seal failures, we had the lab run ISO Particle count to understand the condition of fluid cleanliness as the Solids content of the fluid is 0.124%; typically, solids content is flagged when it reaches 0.5% and beyond. ISO 4406= 21/19/13. This is not atypical cleanliness for a heat transfer system as most systems do not utilize filtration. Please re-sample in 12 months

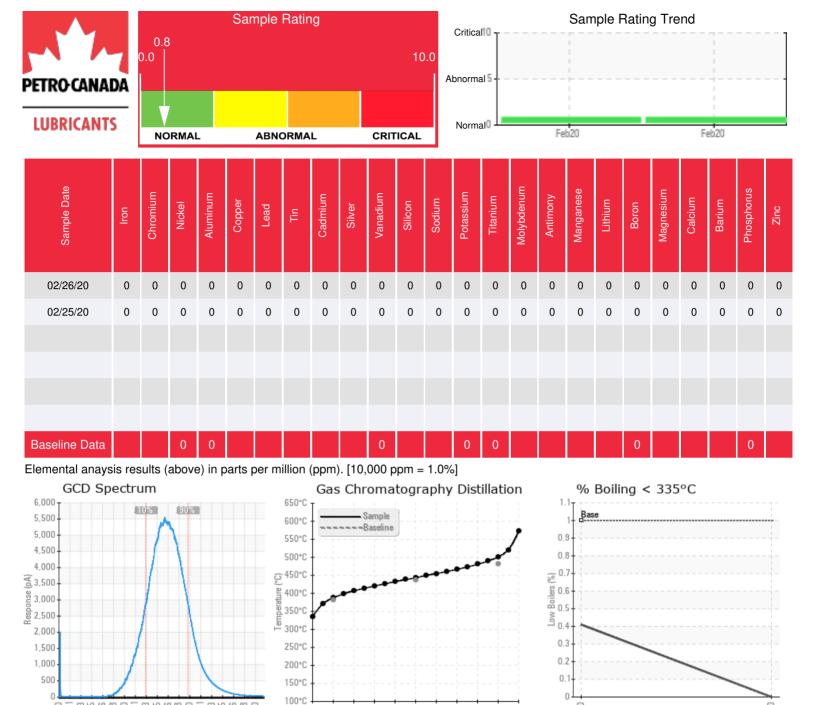
Sample results indicate that the heat transfer fluid is suitable for continued service and appears to be in good condition. (GCD) 10% Distillation Point is marginally high but does not impact the overall health of the fluid. 02/25/20
