## RETURN CARGILL MEAT THAILAND

## System Information

Fluid: PETRO CANADA PURITY FG HEAT TRANSFER FLUID

## Sample Information

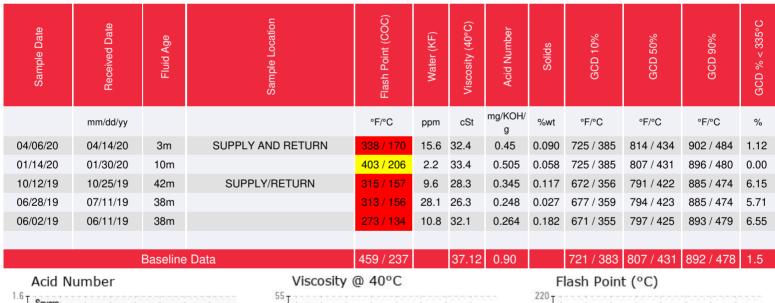
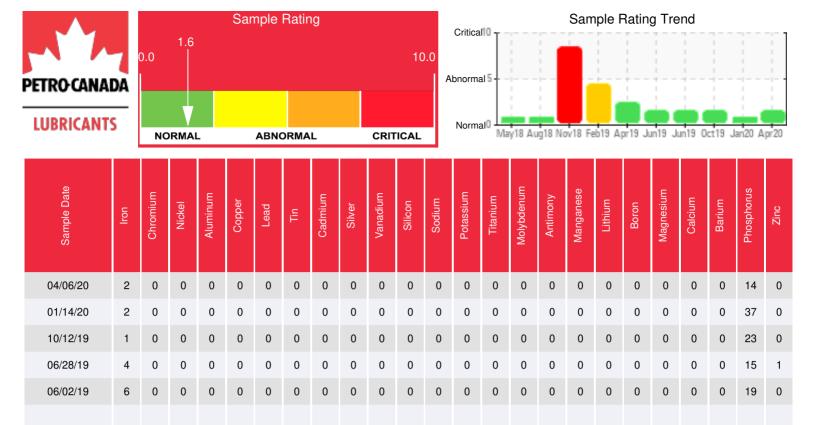
Comments: COC Flash Point is severely low.

Elemental analysis results (above) in parts per million (ppm). [10,000 ppm = 1.0%]

Recommendation: All parameters remain in specification except for the low COC Flash Pt. This has seen lower values in the past but it is important to safely vent the system to remove the low boiling point molecules. Recommend to re-sample in 3 months to check the system after venting.
