SUPPLY CARGILL MEAT THAILAND

System Information

Fluid: PETRO CANADA PURITY FG HEAT TRANSFER FLUID

Lab No: 02348709 Analyst: Philip Riley Sample Date: 04/06/20 Received Date: 04/14/20 Completed: 04/26/20

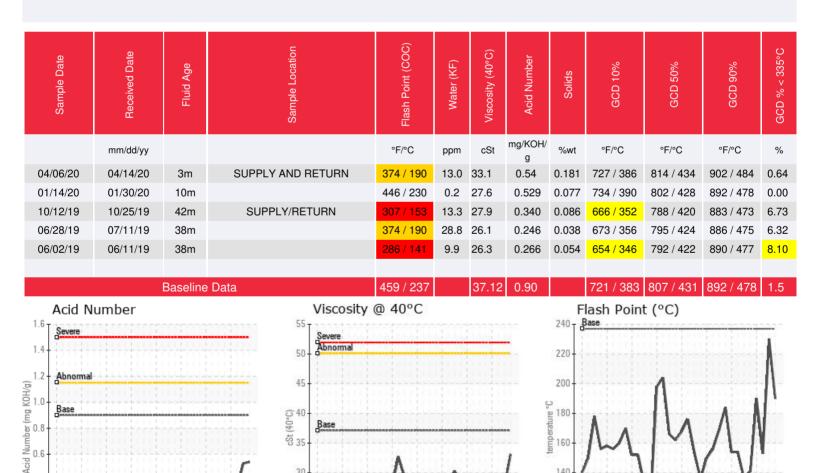
Comments: COC Flash Point is abnormally low.

Historical Comments	
01/14/20	Oil tests to spec and all parameters as expected. Fit for further use and re-sample at normal frequency
10/12/19	Strong evidence of cracking indicated by the lowering viscosity and the low flash point. This looks to have been recovered in the past and if safe to do so the system must be vented. Distillation points remain mainly in line with fresh fluid. Please vent the system and take another sample to check how the system has recovered from removal of the light end molecules COC Flash Point is severely low. (GCD) 10% Distillation Point is marginally low.
06/28/19	The current fluid has normal distillation points. The acid number and solid content are all normal. The current fluid is suitable for operation. Please do the system venting as one of the routine maintenance activities to release the low boiler. Please take one sample in 6 months to monitor the conditions.

06/02/19	The current fluid conditions are slightly better than the previous oil sample two months ago. However, the flash point is still severely low considering the elevated low boiler generated by the thermal cracking? The oil Acid Number and Solid contents are all low. Please conduct a long and effective system venting to release the light oil moisture.

Recommendation: All parameters test to specification with the exception of the COC Flash Pt which is marginally low. The fluid remains suitable for operation, but recommend safe venting if possible to remove the low boiling point molecules. Please resample after normal frequency

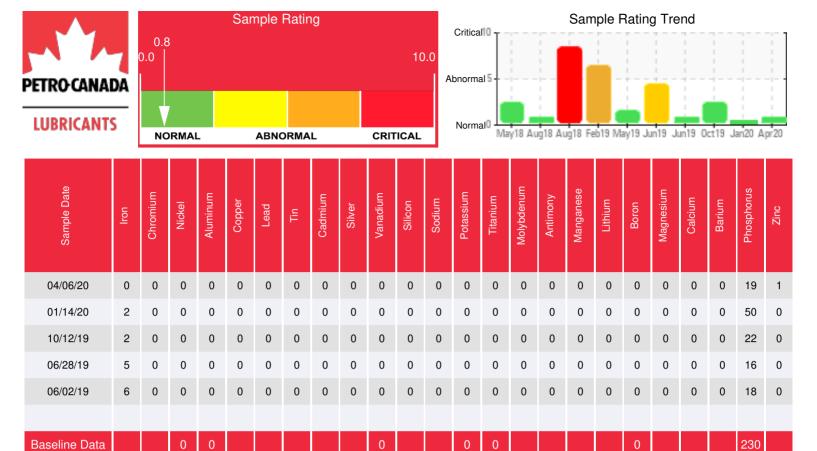
Elemental analysis results (above) in parts per million (ppm). [10,000 ppm = 1.0%]
