WANSON EPC 2500 ES

Customer: PTRHTF40020

LE DUC FINE FOOD BV MEESTER SNIJDERWEG 18

Sample Information

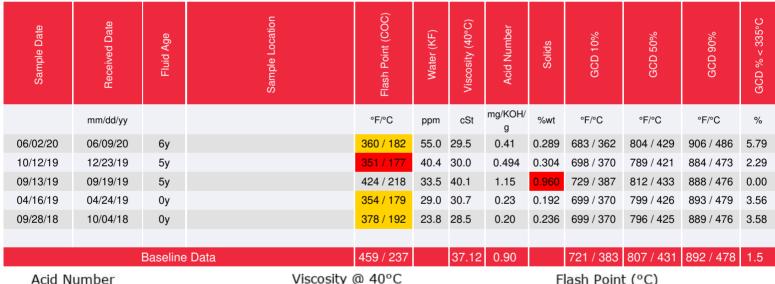
Comments: COC Flash Point is slightly low.

Recommendation: No action required. Send in next oil sample in 6-12 month.

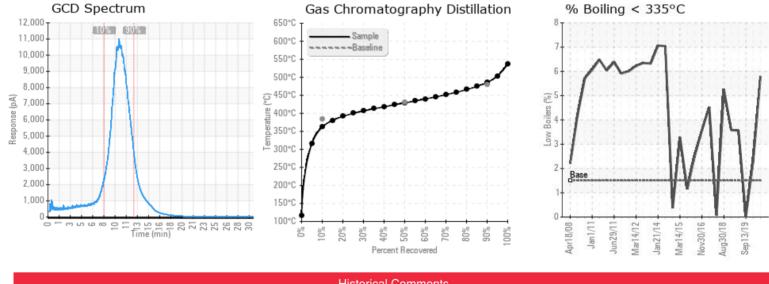
Historical Comments Going through the history of this sample it raises some concerns. In this current sample there has been a loss in viscosity of 10cSt from previous, and a significant drop in flash point to a level that is severely low. The curve shows a little evidence of cracking, but levels of low weight hydrocarbons look fairly low. SOme venting, if it can be done safely, may recover the flash point. I would attempt safe venting and re-sample. If it cannot be done a confirmation or another sample would be recommended as the step downwards in viscosity and flash point shows a worrying trend COC Flash Point is severely low. Was this an oil change? All parameters around Flash Point and viscosity seem to have recovered to normal levels, but the insoluble are very high. Try some filtration to remove insoluble matter and check at normal oil sample interval. Pentane Insolubles levels are severely high. COC Flash Point trending downwards, and must show caution. If it can be recovered safely through any form of venting (although no great volume of light molecules look to be present) if would be worth doing to potentially extend the life of the fluid. Iron ppm levels are noted. COC Flash Point is abnormally low. Looks to have been changed from previous sample. COC Flash Point already low and if safe to do so recommend venting system if possible to remove light molecules that have potentially brought flash point down. All other parameters within allowable limits. COC Flash Point is abnormally low.
