## LINE 1/2

Customer: PTRHTF60002	System Information	Sample Information
BOYNE SMELTERS LTD-RIO TINTO HANDLEY DRIVE QUEENSLAND BOYNE ISLAND, QUE 4680 AUSTRALIA Attn: Heath Mitchell Tel:	System Volume: 20000 ltr Bulk Operating Temp: 514F / 268C Heating Source: Blanket: Fluid: PETRO CANADA CALFLO AF Make:	Lab No: 02363208 Analyst: Philip Riley Sample Date: 03/31/20 Received Date: 07/07/20 Completed: 07/12/20 Philip Riley philip.riley@petrocanadalsp.com

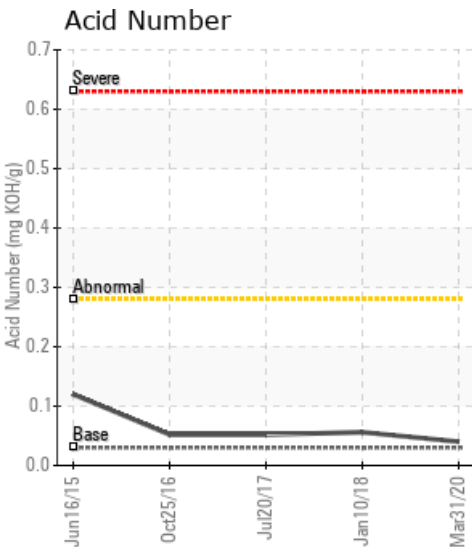
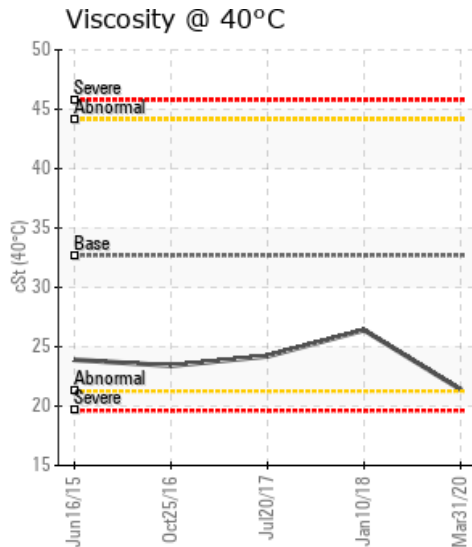
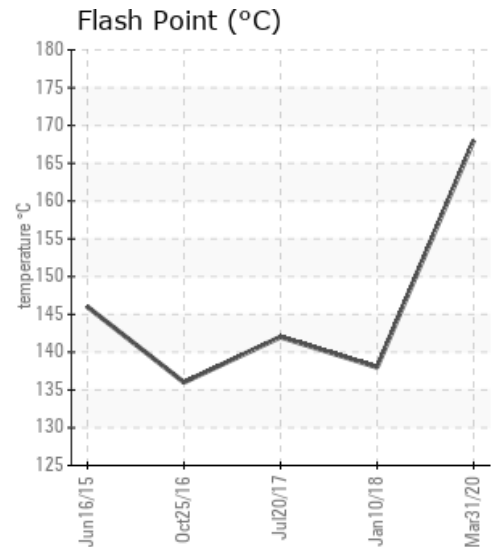
Recommendation: The Flash Pt has been recovered from previous samples, however remains in caution. The viscosity is very low indeed against the fresh oil. Looking at the GCD, the line shows a lot of peaks along the line, indicating thermal cracking. You must look to vent this system (safely) to remove the light end molecules. If a partial change has been done as per the last recommendation, it also indicates the fluid is heading towards end of life as the fluid seems to have a number of areas where it is deteriorating. Please conduct venting and send in another sample after 6 months max.

Comments: COC Flash Point is abnormally low.
