[KEYERA BRAZEAU RIVER GAS PLANT / 3-12-46-14W5] HOT OIL SYSTEM PLT 1

Sample Information

Lab No: 02364496

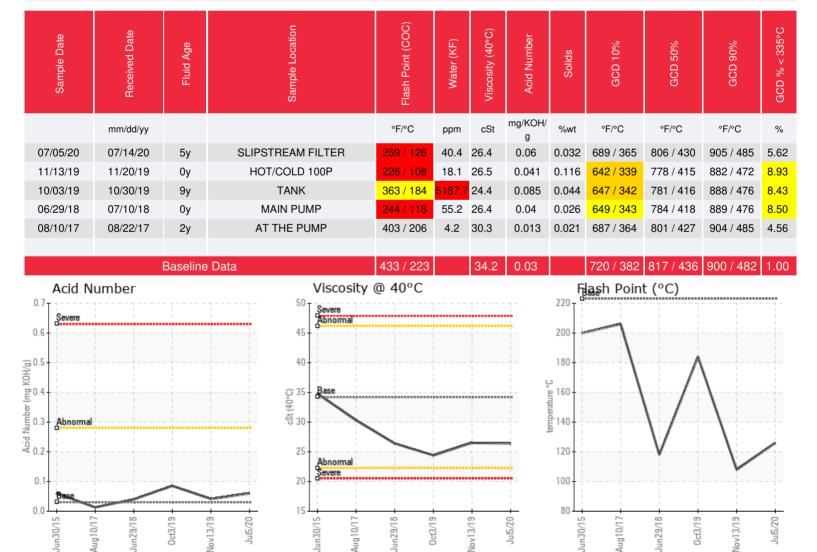
Recommendation: Fluid remains in good condition overall with very little change from the previous sample in Nov 2019. The viscosity is slightly low and the flash point is really low. Given the history these low values are likely from a previous exchanger leak.

Comments: COC Flash Point is severely low.

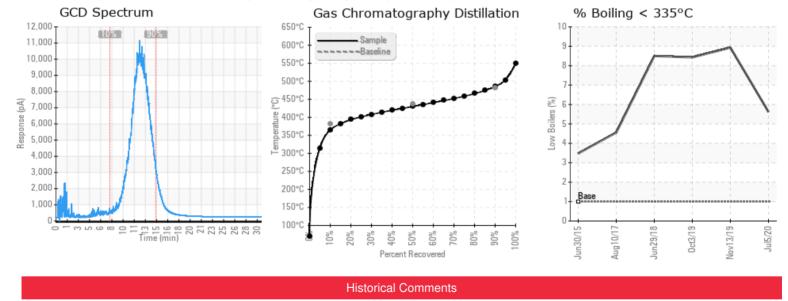
Nice to see absence of water that we saw in the Oct 30 sample. Must have been a bad sample. Suggest submitting annual samples - sooner if fluid gets exposed to stressed condition or exchange leak is suspected. Water content seen in previous sample is resolved. Flash point is very low, GCD 10% & viscosity also low. Likely from previous thermal cracking and/or exchanger leak. However these valve are all very similar to sample from July 2018.

Some level of thermal cracking has occurred over time but no additional degradation since the June 2018 sample. There is significant amount of water present in the fluid sample. Water contamination can sometimes be from a poorly purged sample point. Suggest to submit another sample ensuring a thorough purge of

the fluid sample. Water contamination can sometimes be from a poorly purged sample point. Suggest to submit another sample ensuring a thorough purge of sample point. (GCD) 10% Distillation Point is abnormally low. (GCD) % < 335°C is marginally high. COC Flash Point is marginally low.

The very low flash point, decrease in viscosity and increasing GCD<335 indicate that thermal cracking is occurring. Suggest venting off light ends from fluid. Also

make sure there is adequate circulation to prevent further thermal degradation. COC Flash Point is severely low. (GCD) % < 335°C is marginally high. (GCD) 10% Distillation Point is marginally low.

Fluid remains in very good condition. Very little change from the June 2015 sample. Suggest annual sample submission to proactively monitor fluid condition.
