## **ENERGY PLANT**

WEST FRASER TIMBER CO LTD

# System Information

### Sample Information

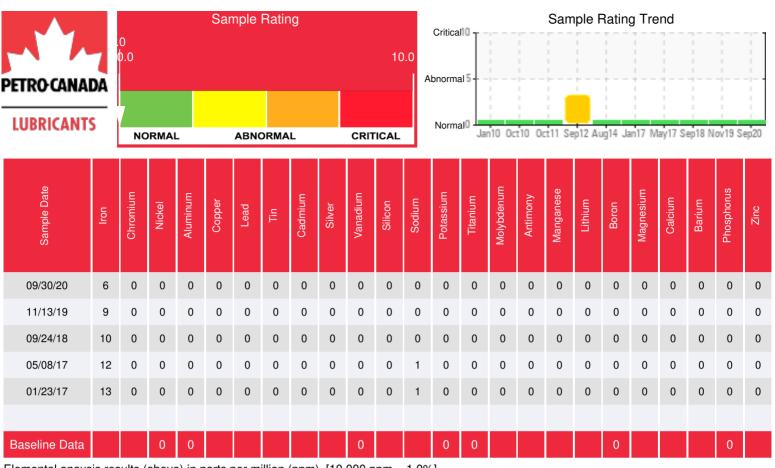
Recommendation: Although results are normal, note minor bump in the sulphur & the slight reduction in the initial boiling point. The gas chromatography results indicate the presence of a lighter hydrocarbon. Resample at the next sample period and continue to monitor the system.

Elemental analysis results (above) in parts per million (ppm). [10,000 ppm = 1.0%]

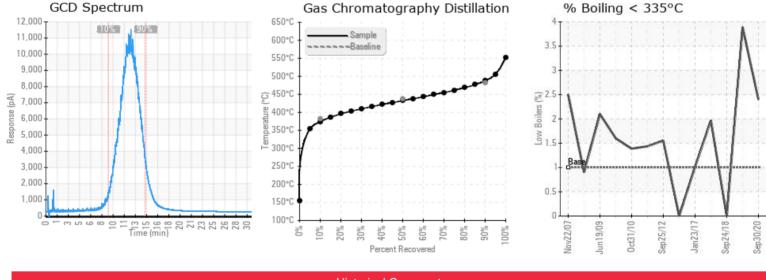
Historical Comments					
11/13/19	Results are normal. Resample at the next interval to monitor a reduction in the COC flash point, and the increase in the GCD % <335C.				
09/24/18	Results are normal.				
05/08/17	Note the initial boiling point reduction from previous samples. Although this result is within normal limits, the reduction in IBP should be noted. A lower initial boiling point indicates that low boilers maybe present in the sample. This condition is normally due to thermal degradation of the sample, however, there is no other analysis result to support that this degradation has taken place. This result can typically be corroborated by a lower flash point, which in this case it cannot. This leads us to believe that the result may be toue to some other deviation? This may also be interpreted as the beginning of thermal degradation process of the system.Low boilers can lead to pump cavitation.All other results are within normal guidelines. We suggest re sampling in 3 months' time to corroborate the reduced IBP result.
