MAIN HOT OIL SYSTEM

Customer: PTRHTF10068

Certainteed - Saint Gobain 1077 PLEASANT ST

Lab No: 02401204 Analyst: Doug Vrooman Sample Date: 01/27/21 Received Date: 02/02/21 Completed: 02/05/21

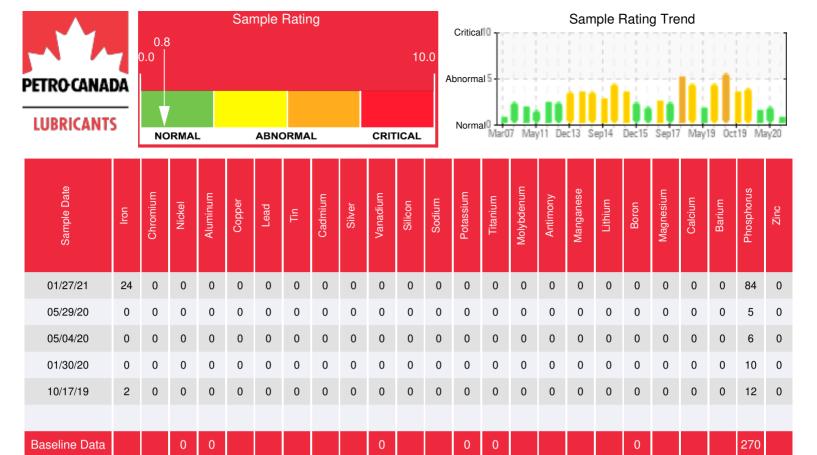
Elemental analysis results (above) in parts per million (ppm). [10,000 ppm = 1.0%]
