FILLER HEATER

Customer: PTRHTF10068

Certainteed - Saint Gobain 1077 PLEASANT ST NORWOOD, MA 02062 USA

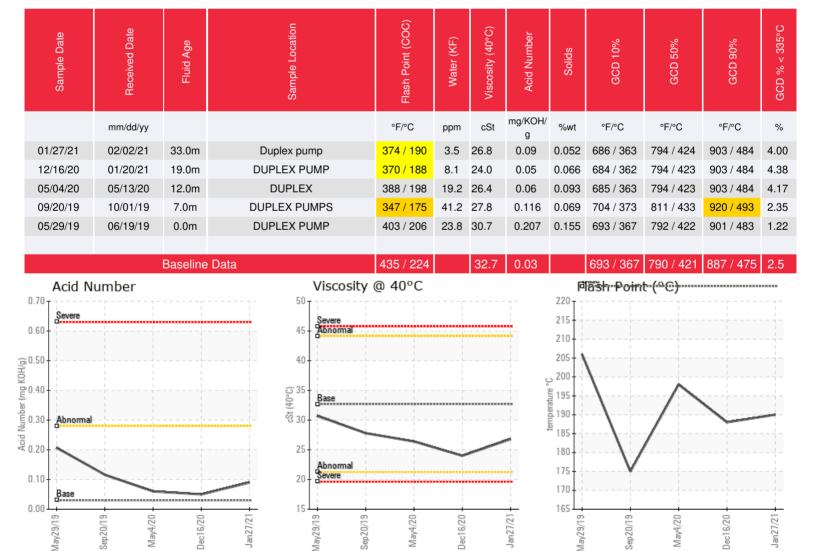
Recommendation: The sample results for the Filler Heater have shown slight improvements with Flash point from 188 to 190. Low boilers GCD 10% 363.4 have shown a slight increase whereas GCD 90% 483.7 have decrease slightly. Acid number has also increased from .05 to .09. Continue to monitor at planned intervals.

Comments: COC Flash Point is marginally low.

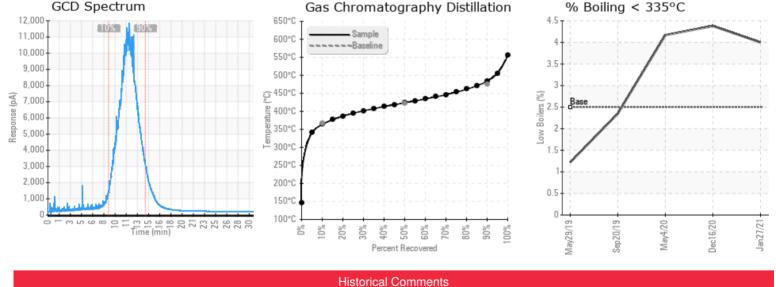
This new Higher Temp system continues to effect HTF condition. We are noticing that the viscosity has dropped to 24.0 cSt @ 40C as well as COC Flash point which has dropped to 188. We recommend Venting (boil-off), as soon as possible. We would also recommend venting more frequently and adding fresh (make-up) fluid more frequently to assist with fluid condition. There is no asphalt contamination reported at this time. COC Flash Point is marginally low. The sample results for the Filler Heater have shown slight improvements with Flash point from 175 to 198. Low boilers GCD 10% 362.9 as well as GCD 90% 483.8 have decrease slightly. Acid number has also decrease from .116 to .06. Continue to monitor at planned intervals. This new Higher Temp system is effecting HTF condition. We are noticing that the viscosity has dropped to 27.8 cSt @ 40C as well as COC Flash point which has dropped to 175. We recommend Venting (boil-off), as soon as possible. We would also recommend venting more frequently and adding fresh (make-up) fluid more frequently to assist with fluid condition. There is no asphalt contamination reported at this time. (GCD) 90% Distillation Point is abnormally high. COC Flash Point is abnormally low. We understand there was some issue with the nitrogen blanket on this new system hence the slight rise in Acid Number. Other properties look normal. Resample in 6 months to closely monitor this new system.
