SOUTH HEATER

Customer: PTRHTF10043	System Information	Sample Information
MALARKY ROOFING PRODUCTS 3131 N. COLUMBIA BLVD PORTLAND, OR 97217 USA Attn: Jeff Tonn Tel: E-Mail: jtonn@malarkeyroofing.com	System Volume: 1200 gal Bulk Operating Temp: 620F / 327C Heating Source: Blanket: Fluid: PETRO CANADA CALFLO HTF Make: AMERICAN HEATING	Lab No: 02404157 Analyst: Ron LeBlanc Sample Date: 01/28/21 Received Date: 02/17/21 Completed: 02/22/21 Ron LeBlanc Ronald.LeBlancSr@hollyfrontier.com

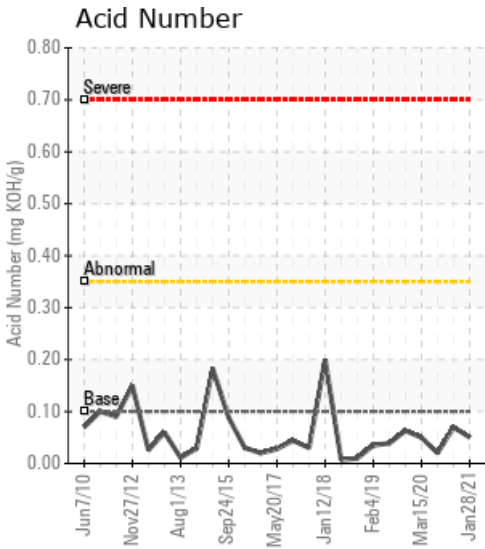
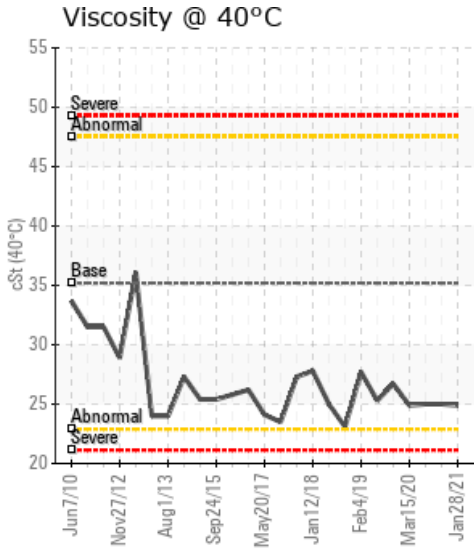
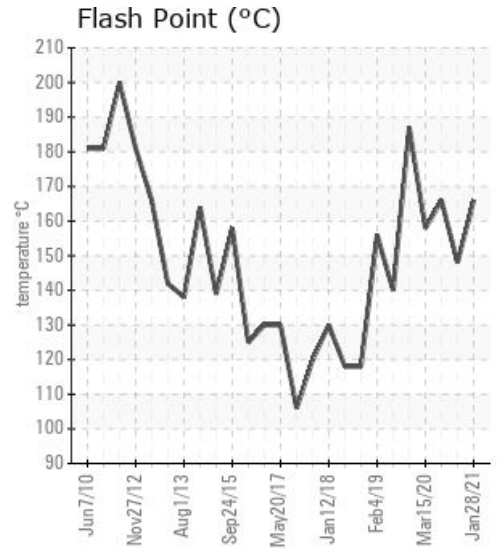
Comments: COC Flash Point is severely low.

Recommendation: (GCD) 10% is low which can cause the flash point to lower significantly indicating low boilers. The low boilers can be removed via the expansion tank. Re-sample in 6 months.
