WANSON BH/INC 1200

Customer: PTRHTF40127

Dalco Foods B.V Everdenberg 50

Lab No: 02414691 Analyst: Luis Rodriguez Sample Date: 04/07/21 Received Date: 04/13/21 Completed: 05/05/21

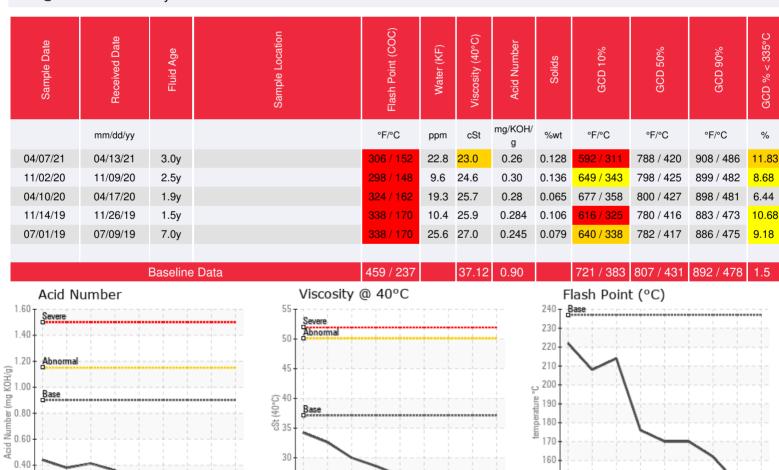
Comments: (GCD) 10% Distillation Point is severely low. COC Flash Point is severely low. (GCD) % < 335°C is abnormally high. Visc @ 40°C is abnormally low.

Recommendation: Flash Point continues to be very low. Viscosity has decreased and evidence of cracking of the oil. Viscosity reduction is consistent and the value is distant from what we expect to see, it supports the theory of lower viscosity molecules being produced. Please try safe venting and check for recovery. Several warnings now on flash point and if recovery attempts have failed, recommend to look towards change.

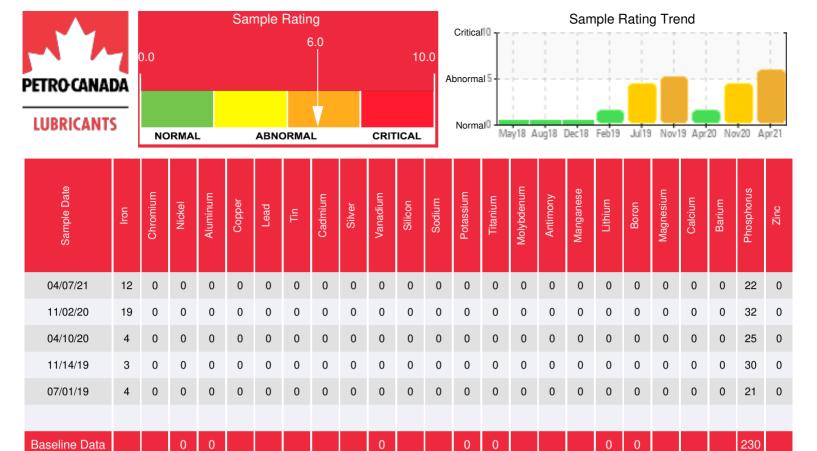
Elemental analysis results (above) in parts per million (ppm). [10,000 ppm = 1.0%]

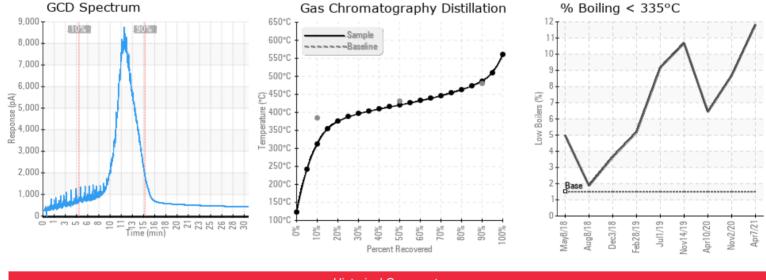
Historical Comments Flash Point (COC) is very low and off specification. Recommend venting the system in order to reduce number of low boilers and recover flash point. COC Flash Point is severely low. (GCD) % < 335°C is marginally high. (GCD) 10% Distillation Point is marginally low. 11/02/20 Whilst sample rating looks to have recovered, other parameters, namely Flash Point and viscosity continue to decline. Viscosity has decreased and evidence of cracking of the oil (shape of curve), also reducing flash point. Please try safe venting and check for recovery. Otherwise, operating at 270C is well above the current flash point which has reduced down to 162C. Several warnings now on flash point 04/10/20 and if recovery attempts have failed, recommend to look towards change. Viscosity reduction is consistent and the value is distant from what we expect to see, it supports the theory of lower viscosity molecules being produced. COC Flash Point is severely low Sample continues to deteriorate. How long has the system been running as there are inconsistent values of age input against previous samples. Viscosity has decreased and evidence of cracking of the oil (shape of curve), also reducing flash point and 10% distillation. Please try safe venting and check for recovery. Otherwise, operating at 270C is well above the current flash point which has reduced down to 11/14/19 170C. Recommned venting and re-sample to check recovery. If continues to deteriorate look towards a change. Please, again, clarify the actual operating time as the sequence does not make sense in previous samples (GCD) 10% Distillation Point is severely low. COC Flash Point is severely low. (GCD) % < 335°C is marginally high FLuid age look sot have reduced? Signs of low flash point and steadily reducing viscosity if trending correct with fluid ages. If the fluid can be safely vented it may recover the flash point, otherwise re-sample in 6 months to check on the fluid degradation COC Flash Point is severely low. (GCD) 10% Distillation Point is 07/01/19 abnormally low. (GCD) % < 335°C is marginally high.
