# [STORM RESOURCES / D-39-D/94-H-3] H-4030

Fluid: PETRO CANADA PETRO-THERM

## Sample Information

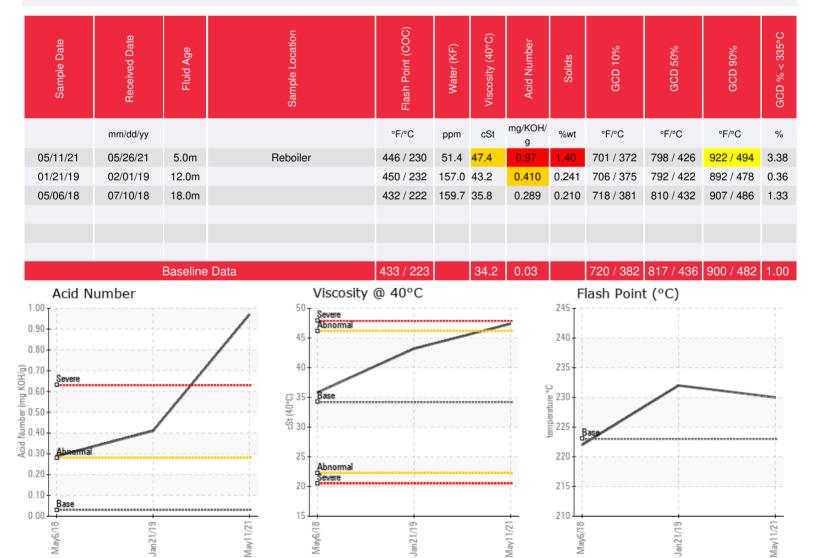
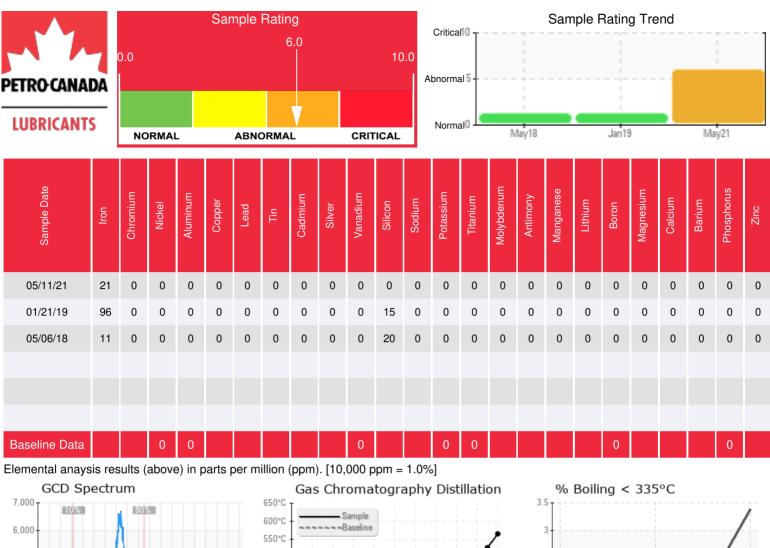
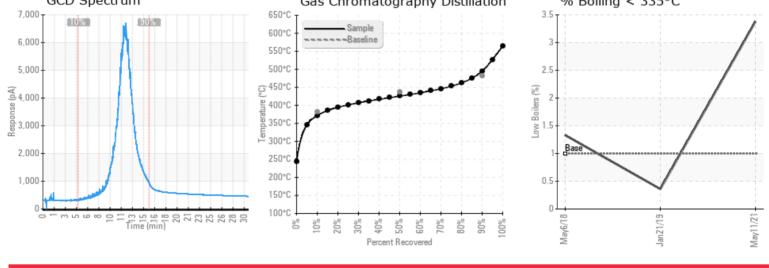
Recommendation: Sample results indicate that the rate of fluid degradation by oxidation has increased since last analysis. Acid Number is at 0.97 (sweetening is recommended ~0.4) and the increase in fluid viscosity, 90% GCD and solids content supports this. It is recommended to make plans to clean system and replace with fresh fluid as oxidation and system fouling can begin to increase exponentially if left. It is critical that blanket gas is properly operation on top of the system's expansion tank to reduce/prevent fluid oxidation. Please contact Petro-Canada's Technical Services to discuss further
