[STORM RESOURCES / D-39-D/94-H-3] H-4030

Fluid: PETRO CANADA PETRO-THERM

Lab No: 02426839 Analyst: Clinton Buhler Sample Date: 06/08/21 Received Date: 06/14/21 Completed: 06/28/21

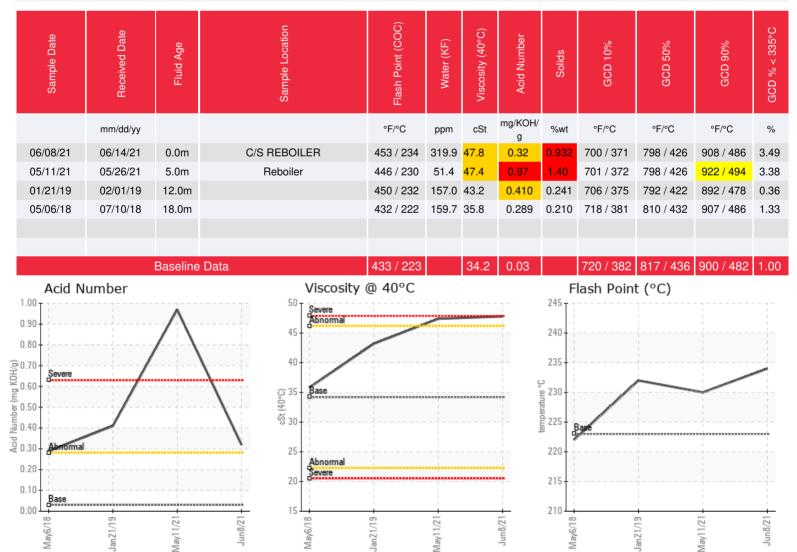
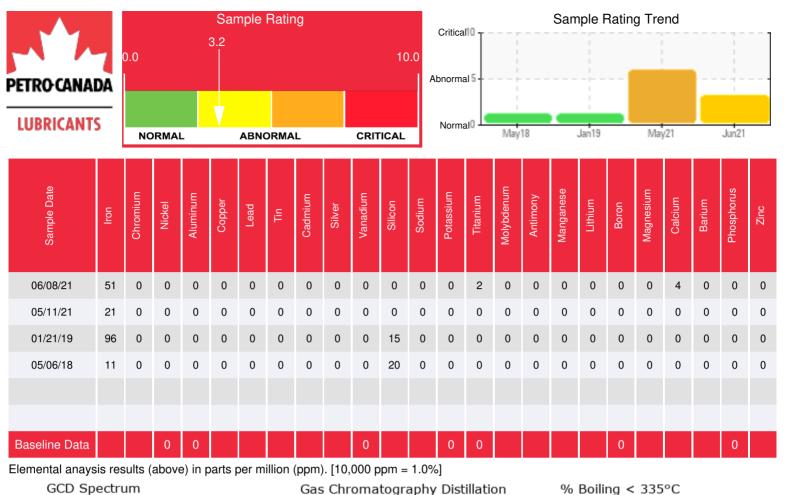
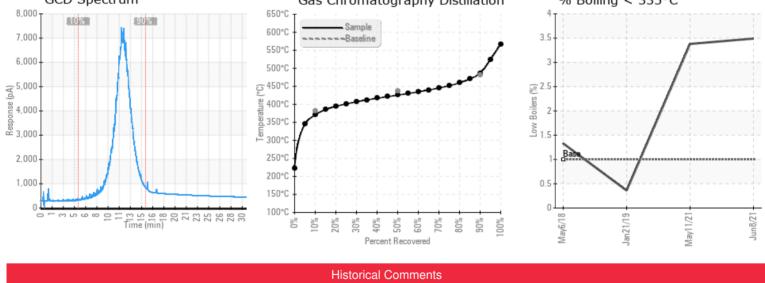
Comments: Pentane Insolubles levels are severely high. Acid Number (AN) is abnormally high. Visc @ 40°C is abnormally high.

Sample results indicate that the rate of fluid degradation by oxidation has increased since last analysis. Acid Number is at 0.97 (sweetening is recommended ~0.4) and the increase in fluid viscosity,

90% GCD and solids content supports this. It is recommended to make plans to clean system and replace with fresh fluid as oxidation and system fouling can begin to increase exponentially if left. It is critical that blanket gas is properly operation on top of the system's expansion tank to reduce/prevent fluid oxidation. Please contact Petro-Canada's Technical Services to discuss further

Sample results indicate that the fluid's acidity is increasing as evidenced by the increase in Acid Number as well as the increased viscosity. These two values may indicate ongoing oxidation. The increase in Iron levels may also indicate that corrosion is ongoing. Consider sweetening of the system to reduce the level of acidity and possible related system corrosion. Ensure blanket gas is operational to reduce the rate of oxidation.Re-sample once sweetening completed. Acid Number (AN) is abnormally high.

sample results indicate that the heat transfer fluid is suitable for continued service. Please note Acid Number at 0.289. This can be an indication of oxidation. Please ensure blanket gas is operational. Iron at 11 ppm can be associated to Acid Number (possible corrosion). Silicon at 20 ppm; this can be from dirt/dust in the system. Please ensure system is sealed from outside contaminants and that fluid transfer devices and hoses are clean. % boil off <335C can be an indication of thermal degradation. As part of a sound maintenance program, periodic venting of low boiling vapors is beneficial. Re-sample in 6-12

Recommendation: Sample results indicate that oxidative fluid degradation is ongoing based on elevated fluid viscosity and Acid Number; fluid acidity may be contributing to corrosion as noted in iron content increase. Elevated solids content of 0.932% may be associated to oxidation but may also be related to thermal degradation (see low boiling vapor content increase to 3.49%). Please ensure blanket gas is properly operational. For large systems, it is generally advised to sweeten the system when acid number reaches ~0.4. Before doing this, another sample should be taken to confirm results. Please ensure that the sample is taken from pump discharge and that the sample valve and tubing is thoroughly purged before gathering a sample.
