## LINE 1/2

Customer: PTRHTF60002	System Information	Sample Information
BOYNE SMELTERS LTD-RIO TINTO HANDLEY DRIVE QUEENSLAND BOYNE ISLAND, QUE 4680 AUSTRALIA Attn: Heath Mitchell Tel:	System Volume: 20000 ltr Bulk Operating Temp: 514F / 268C Heating Source: Blanket: Fluid: PETRO CANADA CALFLO AF Make:	Lab No: 02460672 Analyst: Philip Riley Sample Date: 11/24/21 Received Date: 12/07/21 Completed: 12/13/21 Philip Riley philip.riley@hollyfrontier.com

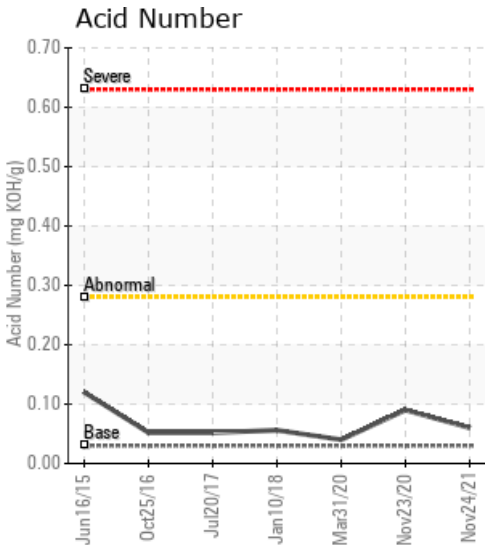
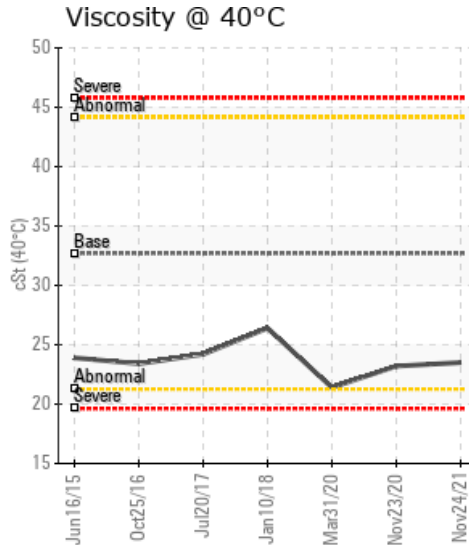
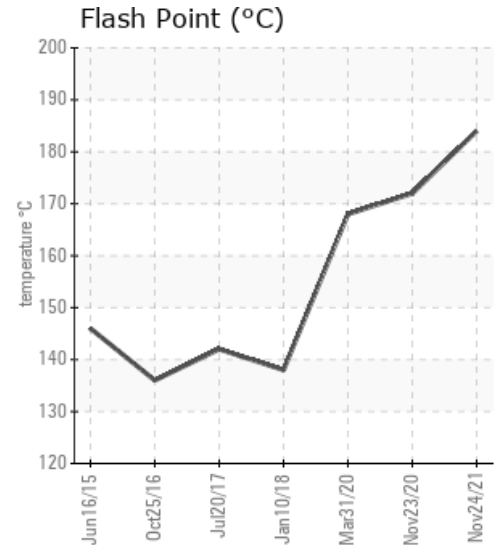
Recommendation: COC Flash Point is low, but improved from the previous sample. Again, there is viscosity drop, and in line with the GCD curve, evidence of fluid cracking (when you link viscosity drop, low flash point, graph). If the system can be safely vented then there is the possibility to recover the flash point and remove the light ends. Conscious this system was changed within the last 12 months, and the results on Line 3 are distinctly different, where the fluid is in very good condition. After venting (if possible), would be interesting to see another sample to see if and how the fluid has recovered somewhat

Comments: COC Flash Point is marginally low.
