Customer: PTRHTF20171	System Information	Sample Information
Keyera Energy - Nordegg River Gas P	System Volume: 42000 ltr	Lab No: 02464406
06-10-044-12w5	Bulk Operating Temp: 356F / 180C	Analyst: Lyle Dach
Nordegg, AB T0M 2H0 Canada	Heating Source:	Sample Date: 12/13/21
Attn: Todd Kjorlien	Blanket:	Received Date: 12/30/21
Tel: (780)514-8988	Fluid: PETRO CANADA PETRO-THERM	Completed: 01/07/22
E-Mail: todd_kjorlien@keyera.com	Make: STEARNS-ROGERS	Lyle Dach
		lyle.dach@hollyfrontier.com

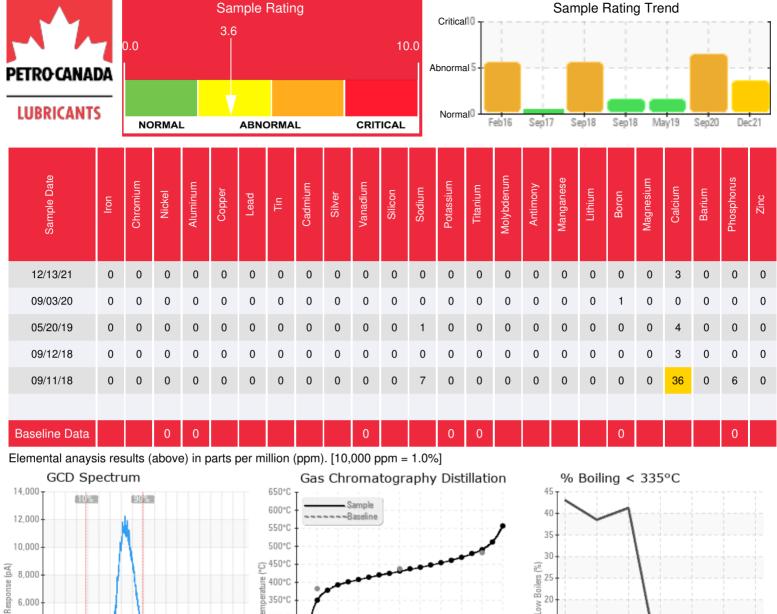
Recommendation: Fluid has improved from last sample but fluids viscosity is still low, GCD%<335°C is on the high side, 10% distillation temperature is low and flash point is also low. Fluid is seeing some thermal degradation or could be contaminated by process fluid. Lower boilers (light ends) should be vented off at the expansion tank. If possible confirm the Petro-Therm has not been contaminated with process products. Resample in 6 months to ensure venting is helping improve fluid quality.
