## TFS H/O SYSTEM #1

Customer: PTRHTF10176	System Information	Sample Information
CERTAINTEED ROOFING	System Volume: 4462 gal	Lab No: 02466163
100 CERTAINTEED DR	Bulk Operating Temp: 553F / 289C	Analyst: Neil Buchanan
JONESBURG, MO 63351 US	Heating Source:	Sample Date: 01/04/22
Attn: Jeff Montgomery	Blanket:	Received Date: 01/13/22
Tel: (952)261-9532	Fluid: PETRO CANADA CALFLO AF	Completed: 01/17/22
E-Mail: jeffrey.d.montgomery@saint-	Make: FSE	Neil Buchanan
gobain.com		neil.buchanan@HFSinclair.com

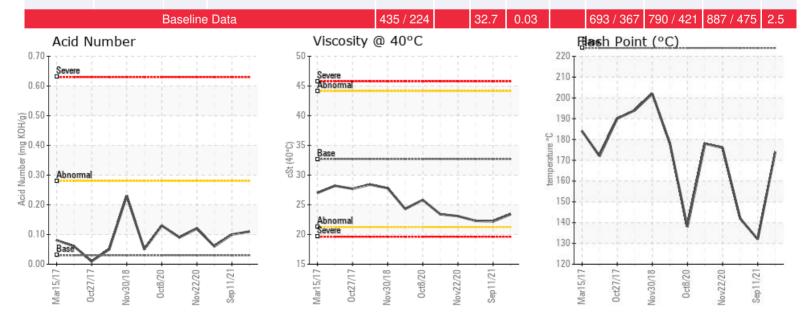
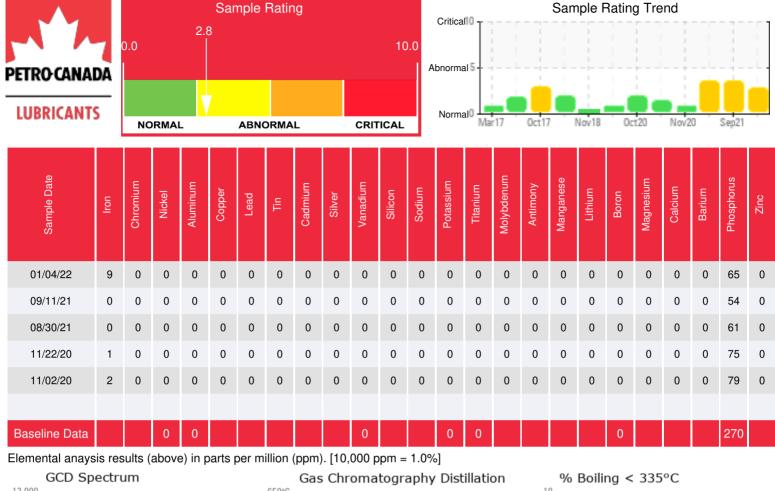
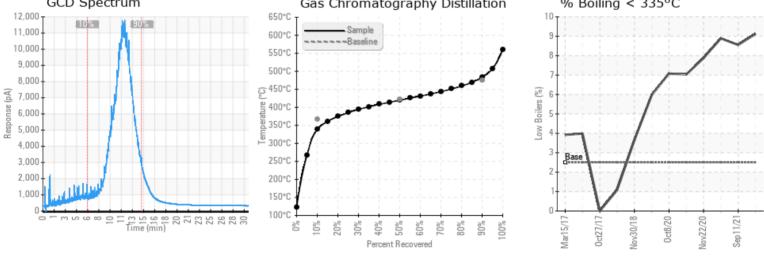
Recommendation: Flash Point is marginally low and this is expected from the GCD results, GCD < 335C and graph, which shows the formation of some low boilers.

Comments: COC Flash Point is abnormally low. (GCD) % < 335°C is marginally high.
