## WANSON 600LNE

Customer: PTRHTF40017	System Information	Sample Information
INTERSNACK BV HAVENSTRAAT 62 GELDERLAND DOETINCHEM, GEL NETHERLANDS Attn: Maintenance Manager Tel: E-Mail:	System Volume: 2600 ltr Bulk Operating Temp: Not Specified Heating Source: Blanket: Fluid: PETRO CANADA PURITY FG HEAT TRANSFER FLUID Make: WANSON	Lab No: 02471935 Analyst: Bill Quesnel CLS,OMA II,MLA-III,LLA-I Sample Date: 02/08/22 Received Date: 02/14/22 Completed: 02/24/22 Bill Quesnel CLS,OMA II,MLA-III,LLA-I

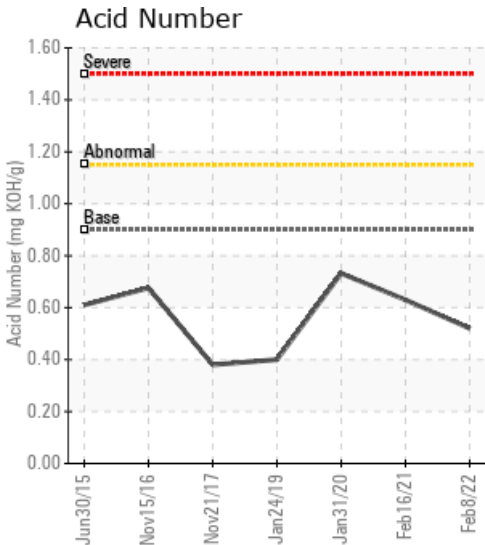
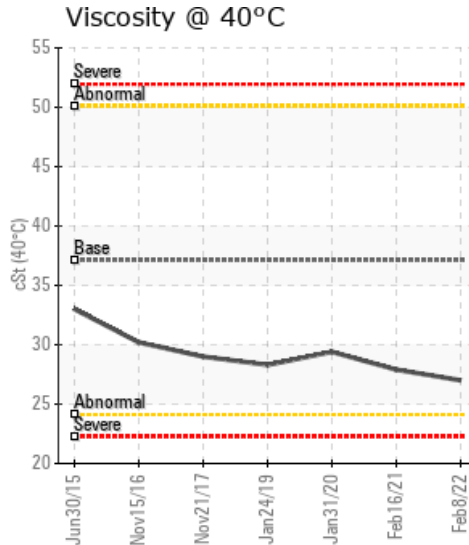
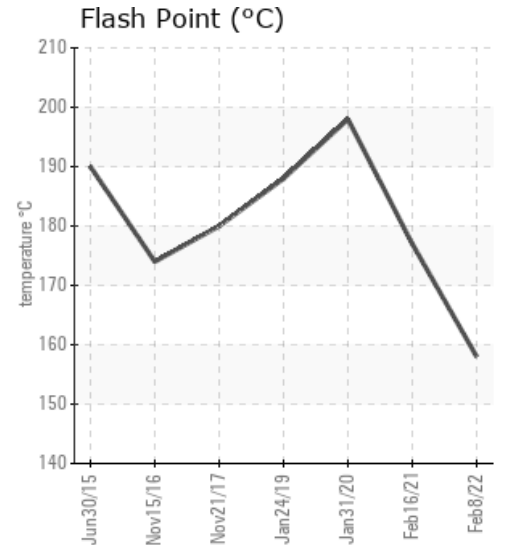
Comments: COC Flash Point is severely low. (GCD) % < 335°C is marginally high. (GCD) 10% Distillation Point is marginally low.

Recommendation: All parameters within acceptable limits except for the COC Flash Point. Ne details on system temperature so please provide these. The fluid has been successfully recovered in recent months, recommend this is attempted by venting if it can be done safely. The GCD curve shows evidence of thermal cracking and the viscosity loss (although not critical) supports this is some way. Recommend system is vented and system temperatures are loaded into the oil analysis program.
