SOUTH HEATER

Customer: PTRHTF10043	System Information	Sample Information
MALARKY ROOFING PRODUCTS 3131 N. COLUMBIA BLVD PORTLAND, OR 97217 USA Attn: Jeff Tonn Tel: E-Mail: jtonn@malarkeyroofing.com	System Volume: 1200 gal Bulk Operating Temp: 620F / 327C Heating Source: Blanket: Fluid: PETRO CANADA CALFLO HTF Make: AMERICAN HEATING	Lab No: 02494763 Analyst: Ron LeBlanc Sample Date: 06/03/22 Received Date: 06/14/22 Completed: 06/16/22 Ron LeBlanc Ronald.LeBlancSr@HFSinclair.com

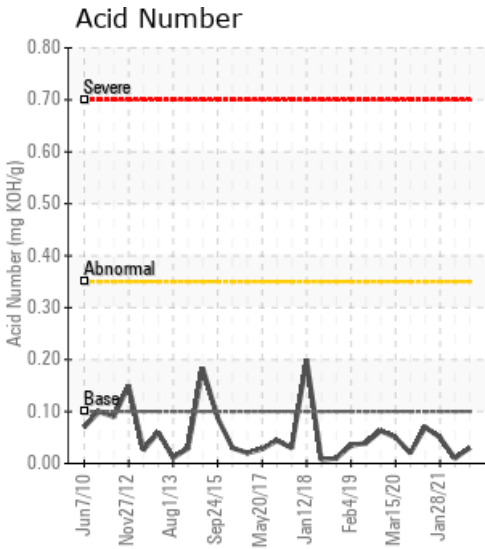
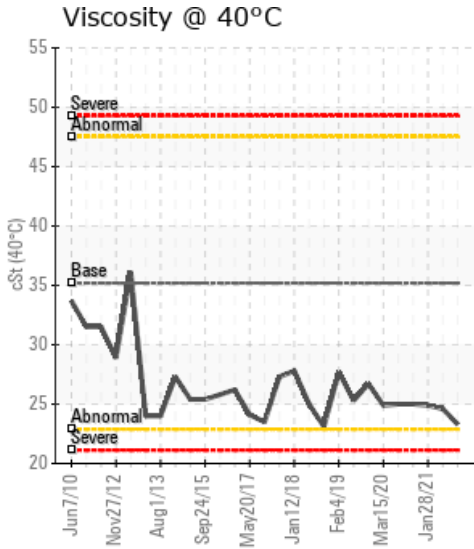
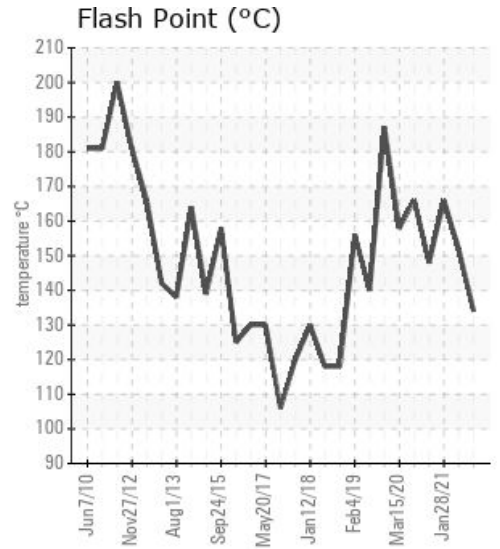
Comments: COC Flash Point is severely low. (GCD) 10% Distillation Point is abnormally low. (GCD) % < 335°C is marginally high.

Historical Comments	
06/24/21	It appears the fluid is being stressed. The flash point is very low. Adding fresh oil can help. Sample again and purge a gallon before capturing sample. COC Flash Point is severely low. (GCD) % < 335°C is marginally high.
01/28/21	(GCD) 10% is low which can cause the flash point to lower significantly indicating low boilers. The low boilers can be removed via the expansion tank. Re-sample in 6 months. COC Flash Point is severely low.
07/10/20	COC Flash point is low which indicates thermal degradation or possible contamination. Be sure the sample port was purged sufficiently before capturing sample oil. COC Flash Point is severely low.
03/18/20	The COC flash point is low again compared to the previous sample. All other typicals remain normal. Could the reported sample have been pulled without proper purging? Adding some new oil would bring up the flash point. Resample in 30 days and purge at least 2 gallons from sample point to evaluate the results. COC Flash Point is severely low.

Recommendation: COC Flash Point is severely low. This typically indicates thermal degradation or the possibility of contamination. (GCD) 10% point is abnormally low. Components boiling below the initial boiling point of the fresh fluid. Low boilers can be removed via the expansion tank.
